DEPARTMENT OF TRANSPORTATION

Contract #: 04-0120F4Cty: SF/ALA Rte: 80 PM: 13.2/13.9File #: 69.28**WELDING INSPECTION REPORT****Resident Engineer:** Siegenthaler, Peter**Address:** 333 Burma Road**City:** Oakland, CA 94607**Report No:** WIR-023924**Date Inspected:** 22-May-2011**Project Name:** SAS Superstructure**OSM Arrival Time:** 1900**Prime Contractor:** American Bridge/Fluor Enterprises, a JV**OSM Departure Time:** 700**Contractor:** Zhenhua Port Machinery Company, Ltd (ZPMC), Changxing Island **Location:** Shanghai, China**CWI Name:** See below**CWI Present:** Yes No**Inspected CWI report:** Yes No N/A**Rod Oven in Use:** Yes No N/A**Electrode to specification:** Yes No N/A**Weld Procedures Followed:** Yes No N/A**Qualified Welders:** Yes No N/A**Verified Joint Fit-up:** Yes No N/A**Approved Drawings:** Yes No N/A**Approved WPS:** Yes No N/A**Delayed / Cancelled:** Yes No N/A**Bridge No:** 34-0006**Component:** OBG**Summary of Items Observed:**

OBG Trial Assembly

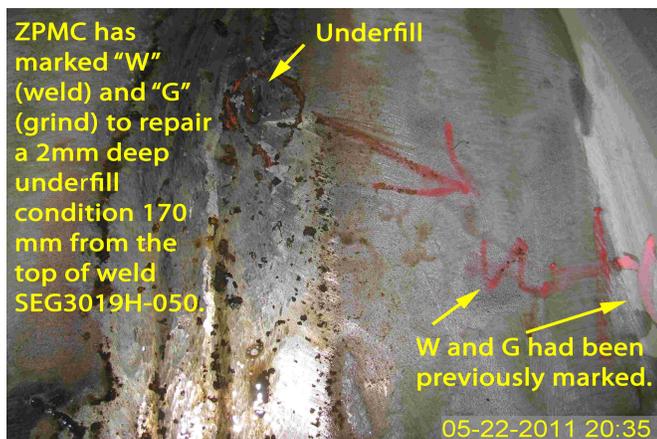
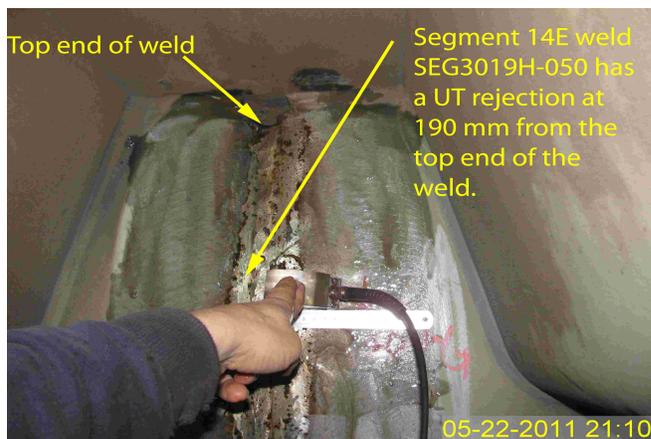
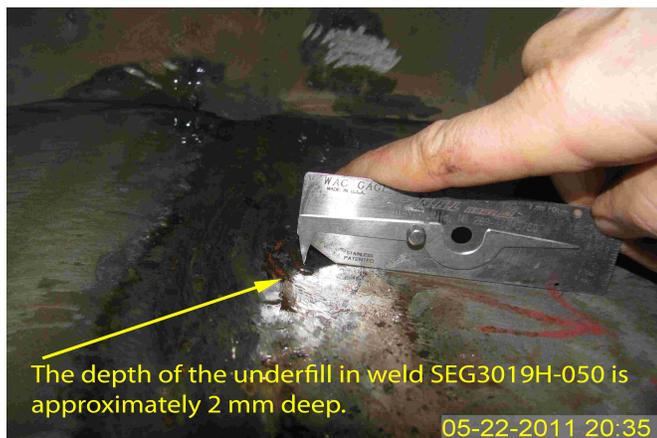
ZPMC issued "Inspection Notification Sheet" number 09217 item #1 informing Caltrans QA that ZPMC is requesting ultrasonic inspections (UT) of OBG segment 14E complete joint penetration welds. This tracker lists approximately two hundred welds. This QA Inspector performed random visual and ultrasonic inspections of the following welds: SEG3019AE-005~007, 012~014, 019~021, 026~028, 033~035, 040~042, 047~049, 054~056, 061~063, 072~074, 123, 126, 129, SEG3019AF-005~007, 012~014, 019~021, 026~028, 033~035, 040~042, 047~049, 072~074, 087~090, SEG3019H-050 and SEG3019B-049. All welds listed above except for weld SEG3019H-050 appear to comply with project specifications. This QA Inspector visually observed weld SEG3019H-050 appears to have a 2mm deep underfill in the face of the weld located approximately 170 mm from the top end of the weld. This area had been previously marked by an unknown person as needing to be welded and ground. This QA Inspector observed a class "A" (2DB) ultrasonic indication located at approximately 190 mm from the top end of the weld. This QA Inspector informed ABF representative Mr. Tao Lin Ying and ZPMC QC Inspector Mr. Sun Tian Liang that an incident report will be issued due to the visual and ultrasonic rejections. For

additional information on these inspections see this QA Inspector's TL6027 Ultrasonic Test Report and the photographs below.
