Contract #: 04-0120F4Cty: SF/ALA Rte: 80 PM: 13.2/13.9File #: 69.28**WELDING INSPECTION REPORT****Resident Engineer:** Siegenthaler, Peter**Address:** 333 Burma Road**City:** Oakland, CA 94607**Report No:** WIR-024028**Date Inspected:** 15-May-2011**Project Name:** SAS Superstructure**OSM Arrival Time:** 1500**Prime Contractor:** American Bridge/Fluor Enterprises, a JV**OSM Departure Time:** 300**Contractor:** Zhenhua Port Machinery Company, Ltd (ZPMC), Changxing Island **Location:** Shanghai, China**CWI Name:** Mr. Li Yan Hua**CWI Present:** Yes No**Inspected CWI report:** Yes No N/A**Rod Oven in Use:** Yes No N/A**Electrode to specification:** Yes No N/A**Weld Procedures Followed:** Yes No N/A**Qualified Welders:** Yes No N/A**Verified Joint Fit-up:** Yes No N/A**Approved Drawings:** Yes No N/A**Approved WPS:** Yes No N/A**Delayed / Cancelled:** Yes No N/A**Bridge No:** 34-0006**Component:** OBG**Summary of Items Observed:**

WELDING INSPECTION REPORT

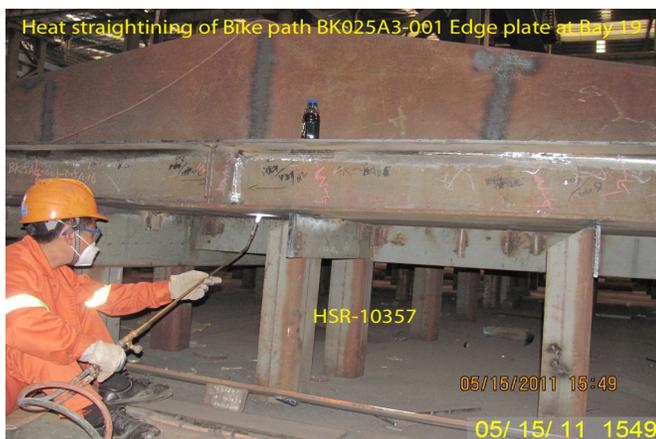
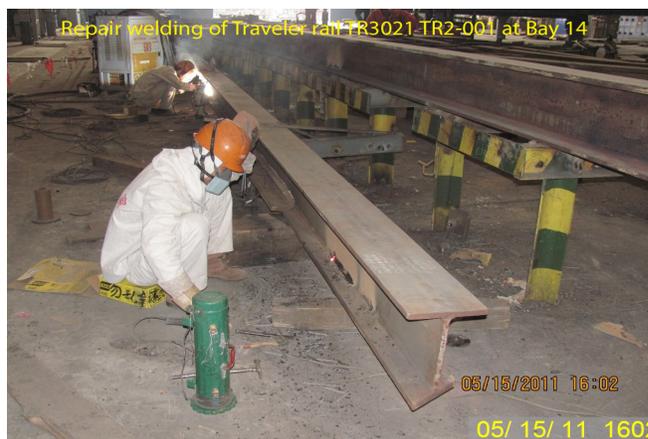
Heat Straightening being performed on Bike Path identified as BK025A3 - 001 by oxy-acetylene flame method to remove the distortion that occurred after welding. ZPMC Quality Control (QC) Inspector is identified as Li Ping present at the location. This activity appeared to comply with the Heat Straightening Report # HSR1 (B) – 10357.
