DEPARTMENT OF TRANSPORTATION

Contract #: 04-0120F4Cty: SF/ALA Rte: 80 PM: 13.2/13.9File #: 99.28**WELDING INSPECTION REPORT****Resident Engineer:** Siegenthaler, Peter**Address:** 333 Burma Road**City:** Oakland, CA 94607**Report No:** WIR-024044**Date Inspected:** 16-May-2011**Project Name:** SAS Superstructure**OSM Arrival Time:** 700**Prime Contractor:** American Bridge/Fluor Enterprises, a JV**OSM Departure Time:** 1700**Contractor:** Zhenhua Port Machinery Company, Ltd (ZPMC), Changxing Island**Location:** Shanghai**CWI Name:****CWI Present:**

Bridge No: 34-0006**Component:** OBG**Summary of Items Observed:**

Trial Assembly Segments 13AE, 13BE, & 13CE

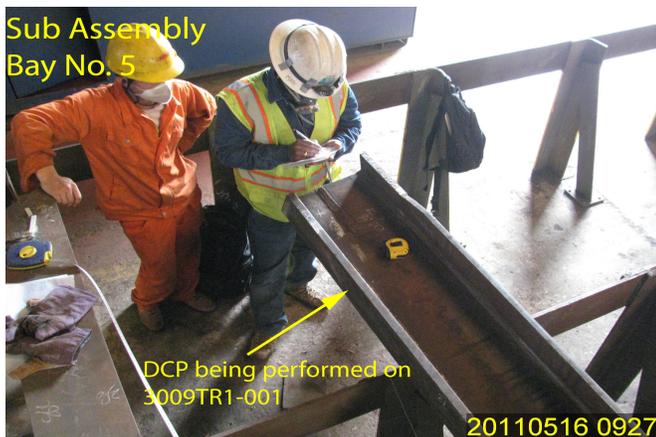
This inspector assisted Manjunath Math with conducting OBG DCP measurement survey on traveler rail component identified as 3009TR1-001. All dimensions were recorded on OBG DCP Measurement Survey: Traveler Rails form, all dimensions are within allowable tolerances, see description of work performed below:

This QA Inspector assisted in performance of Dimension Control Inspection on the Traveler Rails 3009TR1-001 for the following measurements and observed measured dimension in compliance contact document. Inspection was performed against the Inspection Notification # 09144 dated May 16, 2011 at Bay # 5.
