DEPARTMENT OF TRANSPORTATION

Contract #: 04-0120F4Cty: SF/ALA Rte: 80 PM: 13.2/13.9File #: 69.28**WELDING INSPECTION REPORT****Resident Engineer:** Siegenthaler, Peter**Address:** 333 Burma Road**City:** Oakland, CA 94607**Report No:** WIR-024161**Date Inspected:** 30-May-2011**Project Name:** SAS Superstructure**OSM Arrival Time:** 700**Prime Contractor:** American Bridge/Fluor Enterprises, a JV**OSM Departure Time:** 1900**Contractor:** Zhenhua Port Machinery Company, Ltd (ZPMC), Changxing Island **Location:** Shanghai, China**CWI Name:** Mr. An Qing Xiang**CWI Present:** Yes No**Inspected CWI report:** Yes No N/A**Rod Oven in Use:** Yes No N/A**Electrode to specification:** Yes No N/A**Weld Procedures Followed:** Yes No N/A**Qualified Welders:** Yes No N/A**Verified Joint Fit-up:** Yes No N/A**Approved Drawings:** Yes No N/A**Approved WPS:** Yes No N/A**Delayed / Cancelled:** Yes No N/A**Bridge No:** 34-0006**Component:** Orthotropic Box Girder (OBG)**Summary of Items Observed:**

OBG Trial Assembly open yard.

Segment: 13AW

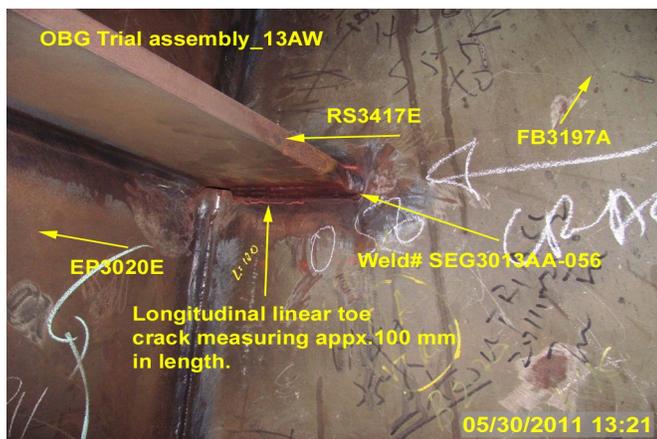
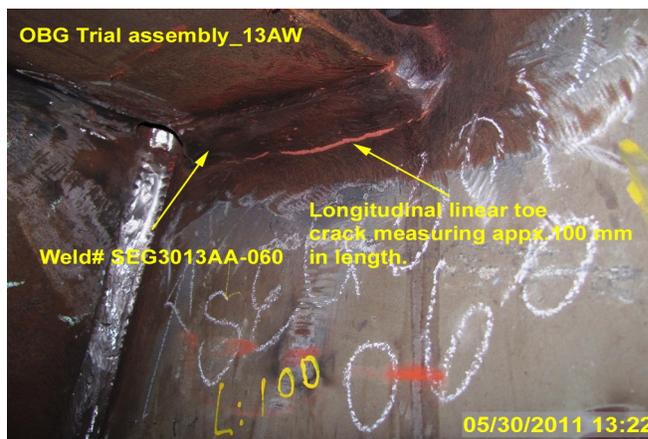
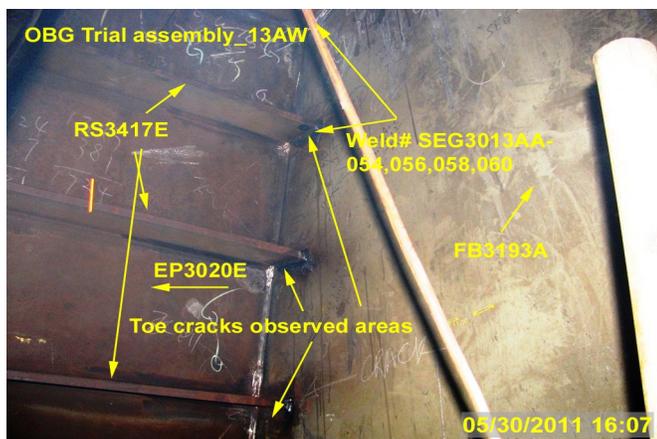
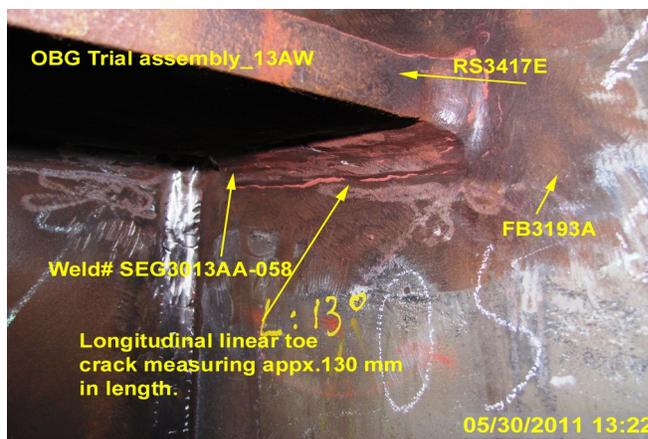
During QA Visual Inspection (VT) and UT review of welds located on OBG between panel point (PP)119+1500 and PP120 (Cross Beam Side), this QA observed following 6 issues:

- One Longitudinal toe crack measuring approximately 100 mm in length.
- The weld is identified as: SEG3013AA-054.
- This weld is a Complete joint penetration (CJP) with reinforcement fillet weld joining horizontal "I" stiffener (RS3417E) to floor beam (FB)-FB3193A.
- The "Y" location is approximately 60 mm from south end of the weld termination.

- One Longitudinal toe crack measuring approximately 100 mm in length.
- The weld is identified as: SEG3013AA-056.
- This weld is a CJP with reinforcement fillet weld joining FB (FB3193A) to horizontal "I" stiffener plate (RS3417E).
- The "Y" location is 0 from south end of the weld termination.

- One Longitudinal toe crack measuring approximately 130 mm in length.
- The weld is identified as: SEG3013AA-058.
- This weld is a CJP with reinforcement fillet weld joining FB (FB3193A) to horizontal "I" stiffener plate (RS3417E).
- The "Y" location is 0 from south end of the weld termination.
- Crack has been removed by grinding to approximately 3 mm in depth.

- One Longitudinal toe crack measuring approximately 100 mm in length.
- The weld is identified as: SEG3013AA-060.
- This weld is a CJP with reinforcement fillet weld joining FB (FB3193A) to horizontal "I" stiffener plate (RS3417E).
- The "Y" location is 0 from south end of the weld termination.

- One Longitudinal toe crack measuring approximately 100 mm in length.
- The weld is identified as: SEG3013AA*-106.
- This weld is a CJP with reinforcement fillet weld joining vertical "I" stiffener (X4469H) to RS stiffener plate (RS3382E).
- The "Y" location is 70 from top end of the weld termination.

- One Longitudinal toe crack measuring approximately 45 mm in length.
- The weld is identified as: SEG3013E-050.
- This weld is a CJP with reinforcement fillet weld joining FB (FB3197A) to horizontal "I" stiffener plate (RS3464M).
- The "Y" location is 20 from bottom end of the weld termination.

- These cracks are clearly marked on the material near the weld.
- Segment 13AW is currently located in the OBG Trial assembly area.

The Notice of Witness Inspection Number (NWIT) is 09301. The cracks are located within an area that has been previously tested and accepted by ZPMC Quality Control (QC) personnel. As per the contract documents, The contractors personnel are required to perform 100% VT and UT inspection of these welds. These cracks were found visually and confirmed by Magnetic Particle Testing (MT).
