DEPARTMENT OF TRANSPORTATION

Quality Assurance and Source Inspection

Contract #: 04-0120F4Cty: SF/ALA Rte: 80 PM: 13.2/13.9File #: 99.28**WELDING INSPECTION REPORT****Resident Engineer:** Siegenthaler, Peter**Address:** 333 Burma Road**City:** Oakland, CA 94607**Report No:** WIR-024292**Date Inspected:** 30-May-2011**Project Name:** SAS Superstructure**OSM Arrival Time:** 700**Prime Contractor:** American Bridge/Fluor Enterprises, a JV**OSM Departure Time:** 1900**Contractor:** Zhenhua Port Machinery Company, Ltd (ZPMC), Changxing Island **Location:** Shanghai**CWI Name:****CWI Present:**

Bridge No: 34-0006**Component:** OBG**Summary of Items Observed:**

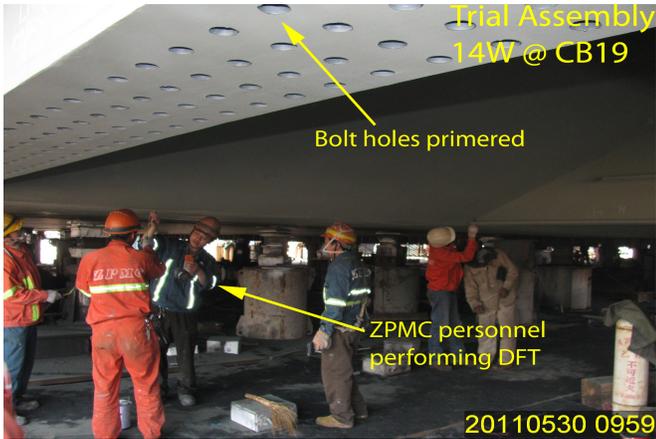
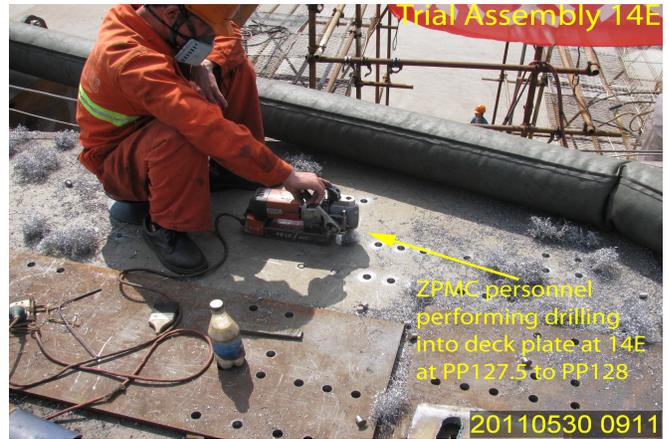
This QA inspector observed the ZPMC personnel performing drilling of FL3 top connection plates, east, and west vertical plates to receive high strength bolting holes at CB19E @ 14AE, also observed match drilling of bolt holes at CB19W @ 14W.

This QA inspector observed ZPMC personnel performing dry film thickness readings, sanding, and painting of drilled holes at CB19W for all faying surface areas connecting FL3 to future bottom plate to be installed.

This QA inspector observed ZPMC personnel drilling into top deck panels at north and south sides of westbound and eastbound segments to accommodate future barrier railing bolting base plates. 13W through 14W @ PP118 to PP128 at east side, 14W @ PP125 to PP127 at west side, 13E through 14E @ PP121 to PP128 at west side, 13E through 14E @ PP123 to PP128 at east side.
