**DEPARTMENT OF TRANSPORTATION**

Quality Assurance and Source Inspection

Contract #: 04-0120F4Cty: SF/ALA Rte: 80 PM: 13.2/13.9File #: 69.28**WELDING INSPECTION REPORT****Resident Engineer:** Siegenthaler, Peter**Address:** 333 Burma Road**City:** Oakland, CA 94607**Report No:** WIR-024341**Date Inspected:** 04-Jun-2011**Project Name:** SAS Superstructure**OSM Arrival Time:** 700**Prime Contractor:** American Bridge/Fluor Enterprises, a JV**OSM Departure Time:** 1900**Contractor:** Zhenhua Port Machinery Company, Ltd (ZPMC), Changxing Island **Location:** Shanghai, China**CWI Name:** Zhu Zhong Hai**CWI Present:** Yes No**Inspected CWI report:** Yes No N/A**Rod Oven in Use:** Yes No N/A**Electrode to specification:** Yes No N/A**Weld Procedures Followed:** Yes No N/A**Qualified Welders:** Yes No N/A**Verified Joint Fit-up:** Yes No N/A**Approved Drawings:** Yes No N/A**Approved WPS:** Yes No N/A**Delayed / Cancelled:** Yes No N/A**Bridge No:** 34-0006**Component:** Orthotropic Box Girder (OBG)**Summary of Items Observed:**

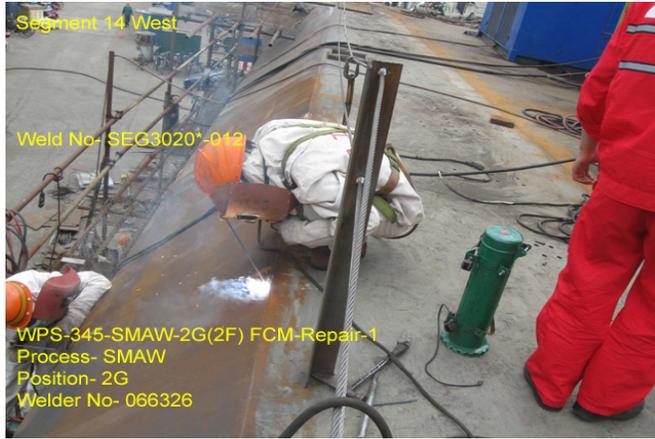
This QA Inspector observed ZPMC qualified welding personnel identified as 066326 perform Shielded Metal Arc Welding (SMAW), weld joint identified as SEG3020\*-012 ; located On Orthotropic Box Girder (OBG) Deck Plate to Edge Plate CJP Weld; ZPMC Quality Control (QC) is identified as Mr. Zhu Lin. This QA Inspector observed the base material appears to have been preheated by an electrical heating element prior to welding. The Welding Repair Report (WRR) was B-WR2115. ZPMC Quality Control (QC) Mr. Zhu Lin was onsite monitoring the welding variables. The welding variables recorded by QC appeared to comply with applicable WPS-345-SMAW-2G (2F) FCM-Repair-1. See attached photo for further details.

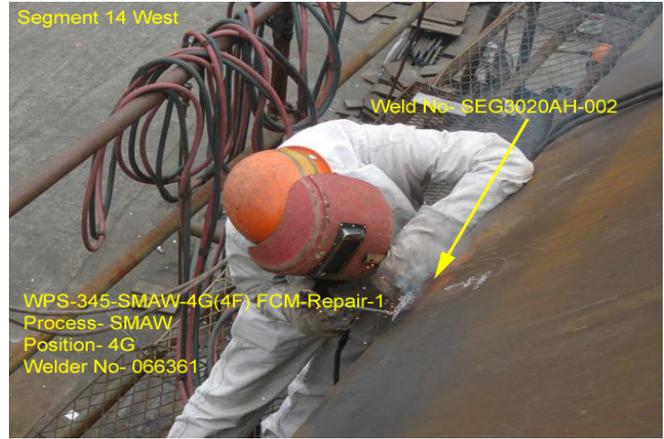
This QA Inspector observed ZPMC qualified welding personnel identified as 066361 perform Shielded Metal Arc Welding (SMAW), weld joint identified as SEG3020AH-002 ; located On Orthotropic Box Girder (OBG) Edge Plate to Edge Plate CJP Weld; ZPMC Quality Control (QC) is identified as Mr. Zhu Lin. This QA Inspector observed the base material appears to have been preheated by an electrical heating element prior to welding. The Critical Welding Repair Report (CWRR) was B-CWR2998. ZPMC Quality Control (QC) Mr. Zhu Lin was onsite monitoring the welding variables. The welding variables recorded by QC appeared to comply with applicable WPS-345-SMAW-4G (4F) FCM-Repair-1. See attached photo for further details.
