Contract #: 04-0120F4Cty: SF/ALA Rte: 80 PM: 13.2/13.9File #: 69.28**WELDING INSPECTION REPORT****Resident Engineer:** Siegenthaler, Peter**Address:** 333 Burma Road**City:** Oakland, CA 94607**Report No:** WIR-025092**Date Inspected:** 30-Jun-2011**Project Name:** SAS Superstructure**OSM Arrival Time:** 1900**Prime Contractor:** American Bridge/Fluor Enterprises, a JV**OSM Departure Time:** 700**Contractor:** Zhenhua Port Machinery Company, Ltd (ZPMC), Changxing Island **Location:** Shanghai, China**CWI Name:** See below**CWI Present:** Yes No**Inspected CWI report:** Yes No N/A**Rod Oven in Use:** Yes No N/A**Electrode to specification:** Yes No N/A**Weld Procedures Followed:** Yes No N/A**Qualified Welders:** Yes No N/A**Verified Joint Fit-up:** Yes No N/A**Approved Drawings:** Yes No N/A**Approved WPS:** Yes No N/A**Delayed / Cancelled:** Yes No N/A**Bridge No:** 34-0006**Component:** OBG**Summary of Items Observed:**

WELDING INSPECTION REPORT

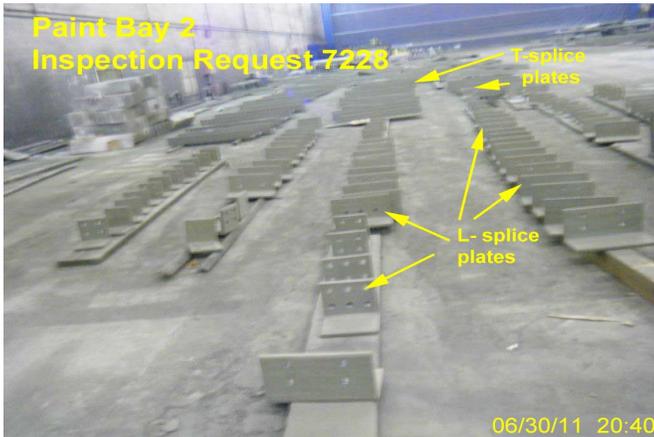
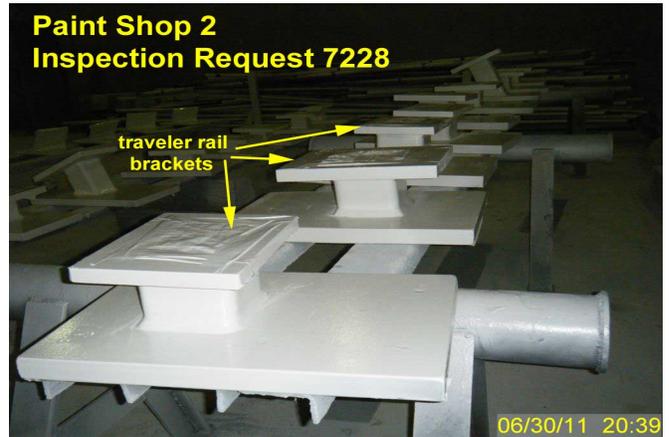
Paint Bay 2

This Caltrop QA Inspector witnessed dry film thickness measurements taken on gray primer for inspection request number 7228. The parts that were tested are T-splice plates, L-splice plates and traveler hanger brackets. ZPMC QC and ABF inspection personnel were present during the inspection and informed this QA of their findings. Gray primer thickness results appear to comply with contract documents. (see photos)
