DEPARTMENT OF TRANSPORTATION

Contract #: 04-0120F4Cty: SF/ALA Rte: 80 PM: 13.2/13.9File #: 99.28**WELDING INSPECTION REPORT****Resident Engineer:** Siegenthaler, Peter**Address:** 333 Burma Road**City:** Oakland, CA 94607**Report No:** WIR-025509**Date Inspected:** 04-Aug-2011**Project Name:** SAS Superstructure**OSM Arrival Time:** 700**Prime Contractor:** American Bridge/Fluor Enterprises, a JV**OSM Departure Time:** 1900**Contractor:** Zhenhua Port Machinery Company, Ltd (ZPMC), Changxing Island **Location:** Shanghai**CWI Name:****CWI Present:**

Bridge No: 34-0006**Component:** OBG**Summary of Items Observed:**

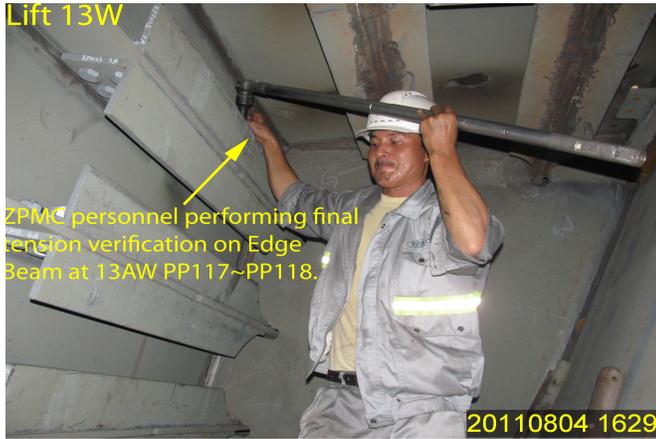
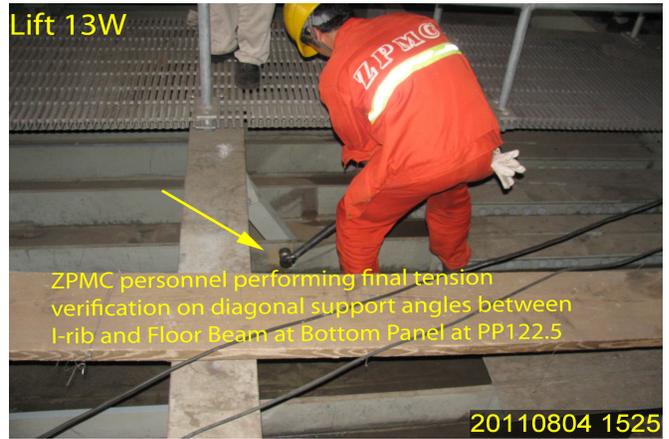
Unless otherwise noted above all items observed on this day appeared to be in general compliance with the applicable contract documents
