QUALITY ASSURANCE -- NON-CONFORMANCE REPORT

Location: Job Site**Report No:** NCR-000720**Prime Contractor:** American Bridge/Fluor Enterprises, a JV**Date:** 27-Apr-2010**Submitting Contractor:** American Bridge/Fluor Enterprises, a JV**NCR #:** ABF-0008**Type of problem:**

Reference Description: Improper Backing Bar Placement**Description of Non-Conformance:**

To: AMERICAN BRIDGE/FLUOR, A JV
375 BURMA ROAD
OAKLAND CA 95607
Date: 28-Apr-2010
Contract No: 04-0120F4
04-SF-80-13.2 / 13.9
Dear: Mr. Charles Kanapicki
Job Name: SAS Superstructure
Attention: Mr. James Bowers
Document No: 05.03.06-000678
Subject: NCR No. ABF-0008

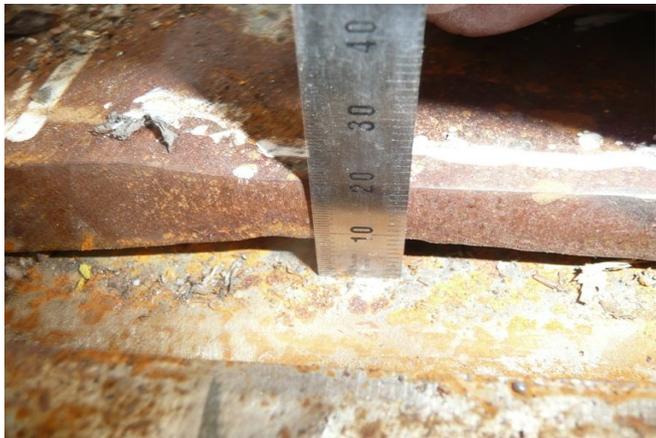
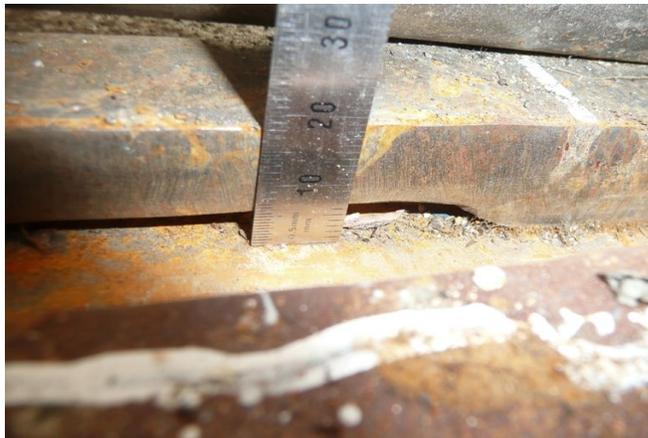
QA Inspectors observed several areas where the gap between the backing bar and the underside of the top deck plate exceeded the tolerance (2mm) of the D1.5 Code.

A1-y=2015mm-2125mm, gap at steel backing 7mm-3mm (length 110mm) 2W side of groove

A1-y=1970mm-2130mm, gap at steel backing 9mm-3mm (length 160mm) 3W side of groove

A2-y=2475mm-3735mm, gap at steel backing 3-3.5mm (length 1260mm)

A2/A3-y=A2-5250mm-A3-600mm, gap at steel backing 3mm-3.5mm (length 750mm)

A4-y=1080mm-1690mm, gap at steel backing 3mm (length 610mm)

A4-y=4350mm-5350, gap at steel backing 3-5mm (approximately 1000mm)

PLA-located at the plate transition north of the number 1 U-Rib, 6mm gap

PLA-located at the junction of plate "A" and "B", 4mm gap

"Steel backing shall be placed and held in intimate contact with the base metal. The maximum gap between steel backing and the base metal at the weld root shall be 2 mm [U16 in.]"

The Contractor proposes that the gap be welded with the SMAW process prior to the subsequent welding of the full length tack welds on either side of the backing bar to the base material and any production SAW welding. The affected area is to be clearly marked and documented by the QC Department on the material for future reference for UT examination purposes.

Department takes no exception to the Contractor's proposal.
