Contract #: 04-0120F4Cty: SF/ALA Rte: 80 PM: 13.2/13.9File #: 1.25B**QUALITY ASSURANCE -- NON-CONFORMANCE REPORT****Location:** USA Hoist**Report No:** NCR-001129**Prime Contractor:** American Bridge/Fluor Enterprises, a JV**Date:** 08-Jul-2013**Submitting Contractor:** American Bridge/Fluor Enterprises, a JV**NCR #:** ABF-0029**Type of problem:**

**Reference Description:** Tower Tie-In Bracket Cracks**Description of Non-Conformance:**

**Attention:** Mr. Bill OSullivan  
**Job Name:** SAS Superstructure

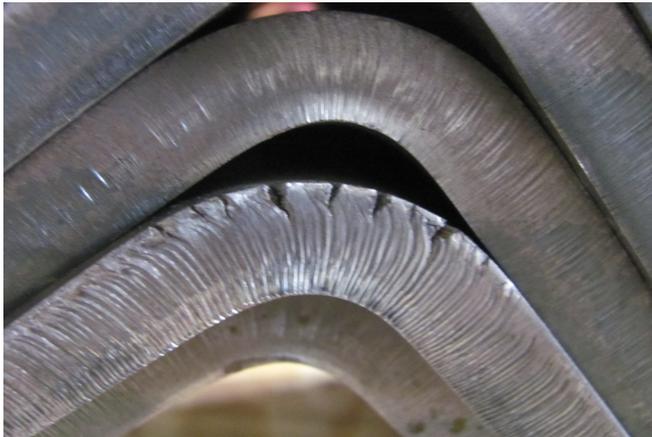
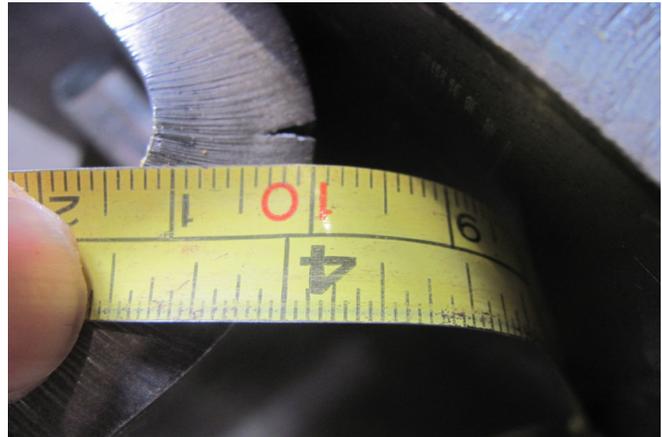
Various tie-in bent plate brackets for the tower elevator masts were noted to exhibit cracks at the corner bends.

Standard Specifications 55-3.07 Bent Plates

"Before bending, the corners of the plate shall be rounded to a radius of 2 mm throughout that portion of the plate at which the bending is to occur."

The load bearing cold bent plates are cracked. Assurance needs to be provided to show that the proposed grinding process completely eliminates all cracks.

The contractor proposes to grind down the cracks without any additional NDT.

The contractor replaced all defective brackets
