Contract #: 04-0120F4  
 Cty: SF/ALA Rte: 80 PM: 13.2/13.9  
 File #: 83.25B

## QUALITY ASSURANCE -- NON-CONFORMANCE REPORT

**Report No:** NCR-001116

**Reference Description:** PPW10 & PPW12 Suspender Rope Zinc Buttons

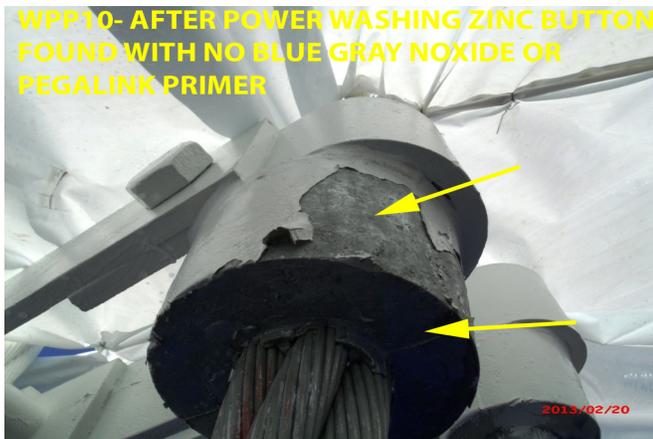
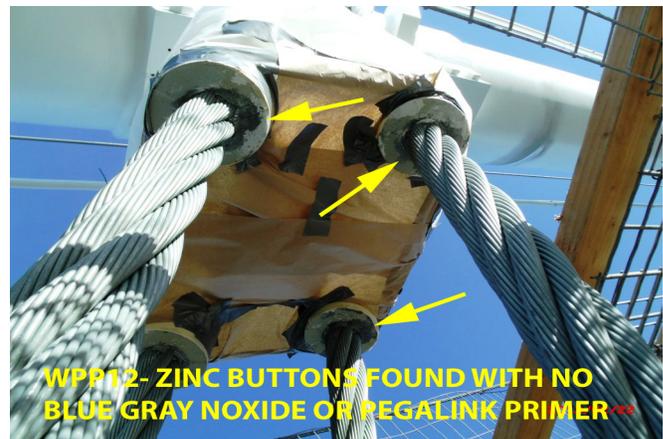
The Contractor has applied Gravel Gray Noxide and DTM 3700 prior to applying the Pegalink primer and the Blue Gray Noxide on the Zinc Buttons.

Applicable reference: 10-1.71 Clean and Paint Cable System , Materials:

“The cable paint system shall consist of a primer, a two intermediate coat Noxyde Plus paint system, or equal, and a finish coat. The two intermediate coats shall be 100 percent Noxyde Plus.”

Zinc Buttons on Suspenders have been Finish Painted at WPP10 and WPP12 without all of the previous coats having been applied – See NCR #CCC-0007.

In addition and further to the NCR being generated, further locations have also been found at WPP14, WPP18 and WPP20 to have been finish coated without application of the previous coats.

Inspect all painted Zinc Button locations in the presence of the Engineer to determine whether all coats of paint have been applied as required by the Contract Documents. At all non-complying locations, remove the paint and then re-apply the full coating system as required by the Contract.

The Contractor removed the coating from the Zinc Buttons and reapplied the coating system in the proper sequence.
