Contract #: 04-0120F4Cty: SF/ALA Rte: 80 PM: 13.2/13.9File #: 70.25B**QUALITY ASSURANCE -- NON-CONFORMANCE REPORT****Location:** Murooran Japan**Report No:** NCR-000140**Prime Contractor:** American Bridge/Fluor Enterprises, a JV**Date:** 04-Jun-2008**Submitting Contractor:** Japan Steel Works**NCR #:** JSW-0003**Type of problem:**

**Attention:** Mr. James Bowers  
**Job Name:** SAS Superstructure

**Subject:** NCR No. JSW-0003  
**Document No:** 05.03.06-000115

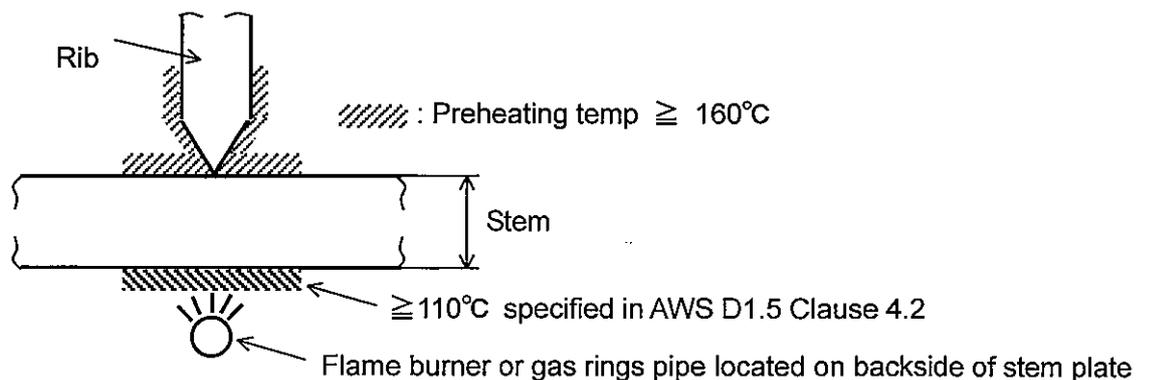
JSW explained the preheat temperature 160°C for tack weld could not be kept in wide area and whole thickness of the heavy plate because the large expansion of the material by preheat would disturb securing the tolerance limits of dimension of the structure.

It was the reason why the preheating was done only from the welded side when the Rib was tack welded to the Stem.

For tack welding of the Deviation Saddle W2E3, we would like to take following countermeasure. The temperature of opposite side of the Stem during tack weld should be higher than 110°C which is specified as minimum preheat temperature for A709 Gr.485W described in Clause 4.2 "Preheat and Interpass Temperature Requirement" of AWS D1.5.

When the temperature is not enough for tack weld by one side heating, preheat using a flame burner or gas rings set up partially from opposite side will assist. (Refer to the Sketch)
