Contract #: 04-0120F4Cty: SF/ALA Rte: 80 PM: 13.2/13.9File #: 69.25B**QUALITY ASSURANCE -- NON-CONFORMANCE REPORT****Location:** Shanghai, China**Report No:** NCR-000012**Prime Contractor:** American Bridge/Fluor Enterprises, a JV**Date:** 30-Sep-2007**Submitting Contractor:** Zhenhua Port Machinery Company, Ltd (ZPMC), Changxing Island**NCR #:** ZPMC-0008**Type of problem:**

**Subject:** NCR No. ZPMC-0008

**Reference Description:** Repairs to skin plate welds greater than 10% in length on the 114m Mock-up

**PROJECT: San Francisco Oakland Bay SAS Bridge Superstructure**  
**Caltrans Contract No. 04-0120F4**  
**ABF Job No. 660110**

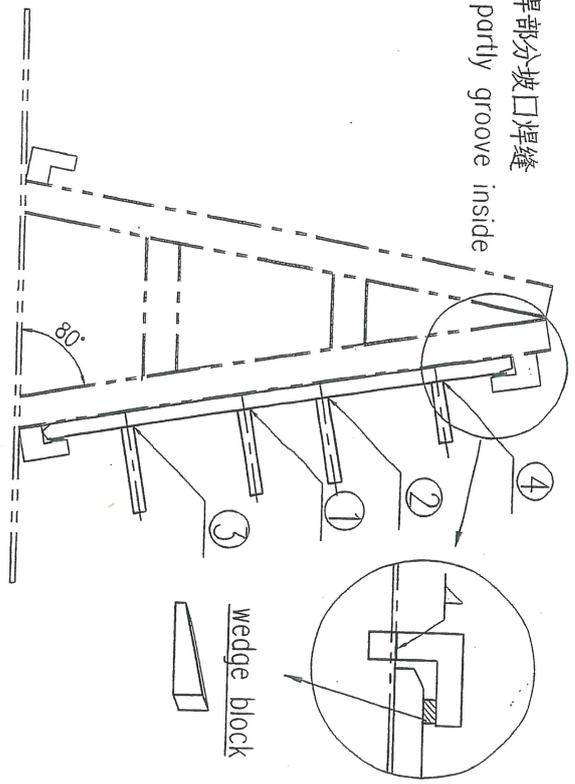
位置1

正面焊部分坡口焊缝  
Weld partly groove inside

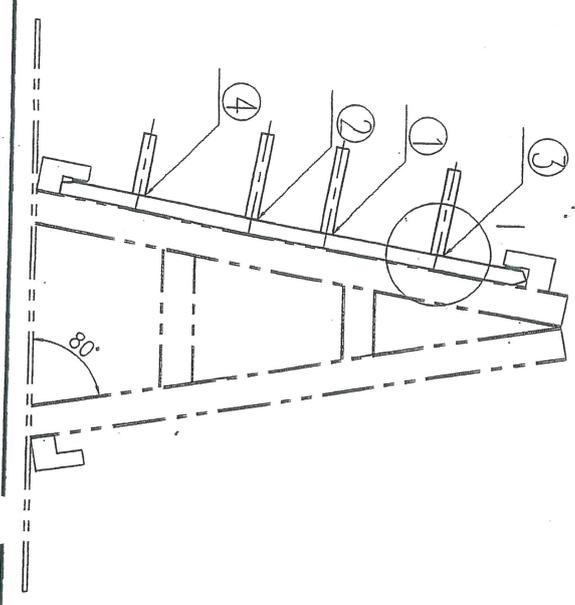
位置2

翻身碳刨清根, 焊部分坡口焊缝  
Weld partly groove outside

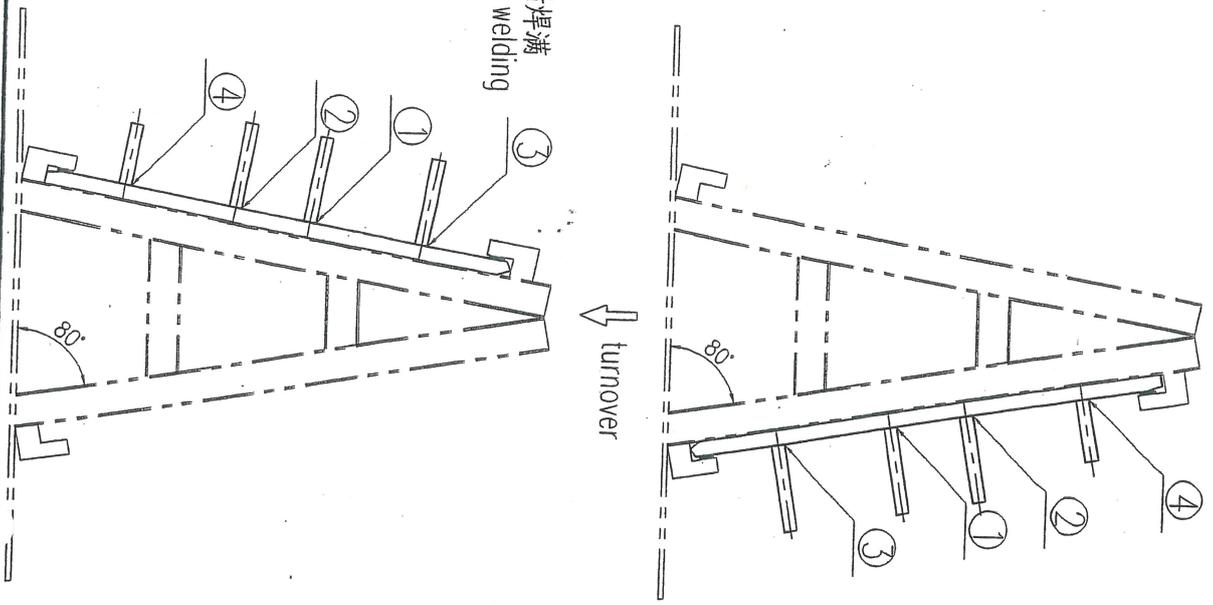
位置3  
翻身  
weld after turnover

翻身  
finish welding

3.4. 碳刨结束后, 将碳刨面打磨光亮, 并利用模板检验碳刨的角度。  
3.4. Grind surface to a smooth finish and check profile of back gouge with template.

3.5. 继续对碳刨面一侧进行烧焊, 并监测焊缝以确保3.6. 焊接时采用多次翻身控制纵向筋垂直度是可行的变形控制方法。  
3.5. Weld to part fill back gouged side and monitor weld to ensure distortion control measures are adequate by rotating the Skin plate when required to control the verticality of stiffener.

3.6. 焊后检查纵向筋垂直度, 如需要按批准的WQCP要求热校正纵向筋垂直度。  
3.6. Check the verticality of the stiffeners and adjust by heat straightening if required following the approved WQCP.

3.7. NDT检测要求: 焊接后进行100% UT及VT检查。  
3.7. Perform NDT, VT and UT 100%.
