Contract #: 04-0120F4Cty: SF/ALA Rte: 80 PM: 13.2/13.9File #: 69.25B**QUALITY ASSURANCE -- NON-CONFORMANCE REPORT****Location:** ZPMC Changxing Island - Shanghai, China**Report No:** NCR-000013**Prime Contractor:** American Bridge/Fluor Enterprises, a JV**Date:** 15-Oct-2007**Submitting Contractor:** Zhenhua Port Machinery Company, Ltd (ZPMC), Changxing Island**NCR #:** ZPMC-0012**Type of problem:**

Job Name: SAS Superstructure

Subject: NCR No. ZPMC-0012

Reference Description: Repairs to skin plate welds greater than 10% in length on the 114m Mock-up

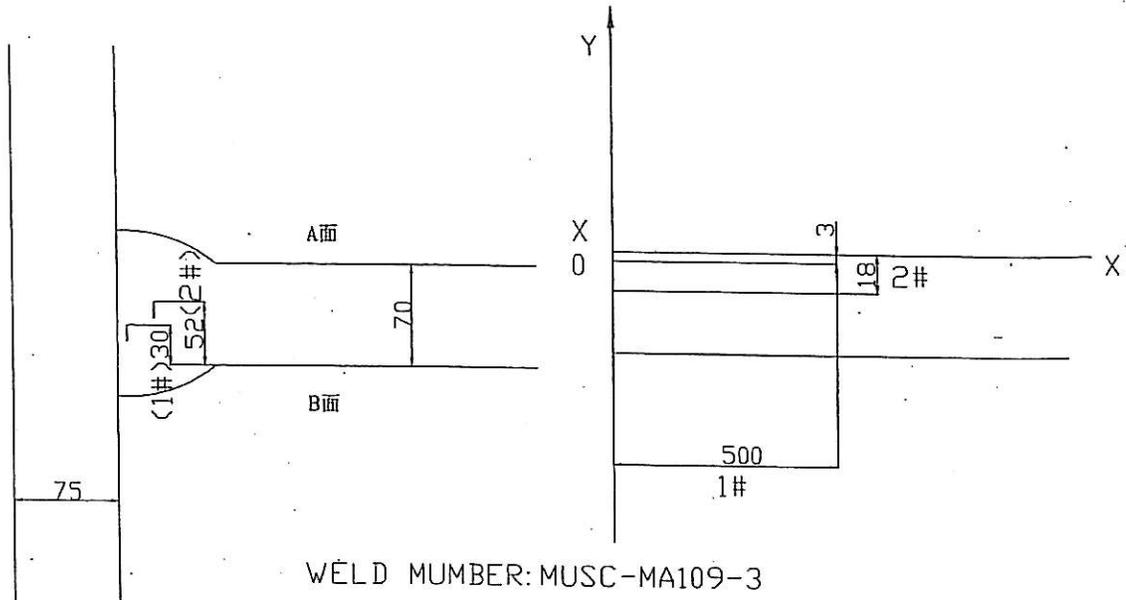
Rejected indication found by ultrasonic inspection exceeds 10% of the weld size. MUSC-MA109-3

焊缝缺陷描述:

Description of welding discontinuity:

UT检测缺陷的返修长度超过10%。

Caused:

1. 焊道没有清除干净。
2. 返修深度错误。
1. Did not clear the weld pass completely.
2. Depth of repair had mistakes.

Disposition:

返修的焊缝的工艺应该与筋板与面板的CJP焊接工艺及批准的WPS一致，修改的模型制作工艺现在正在使用和将反映采用了附上的修改了的筋板与面板CJP的焊接工艺。

Repair welding shall be in according with the attached Stiffener to Skin Plate CJP welding Procedure and an approved WPS. Revisions to the Mockup Fabrication Procedure are currently in process and shall reflect the revisions adopted by the attached Stiffener to Skin Plate CJP welding procedure.
