Contract #: 04-0120F4Cty: SF/ALA Rte: 80 PM: 13.2/13.9File #: 69.25B**QUALITY ASSURANCE -- NON-CONFORMANCE REPORT****Location:** Shanghai, China**Report No:** NCR-000025**Prime Contractor:** American Bridge/Fluor Enterprises, a JV**Date:** 25-Dec-2007**Submitting Contractor:** Zhenhua Port Machinery Company, Ltd (ZPMC), Changxing Island**NCR #:** ZPMC-0024**Type of problem:**

Job Name: SAS Superstructure

Subject: NCR No. ZPMC-0024

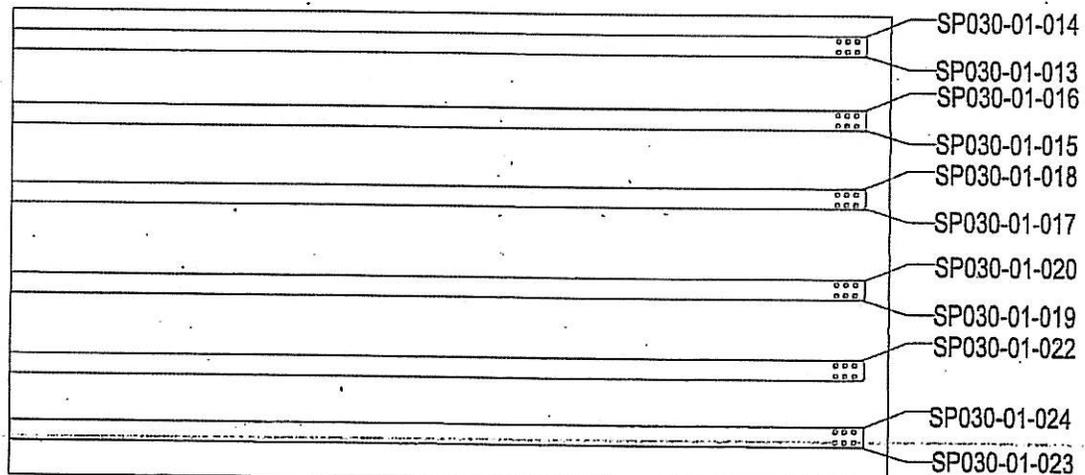
Draft of welding discontinuity:

There are not the enough size in 11 welds of 3B-C5 east box bottom plate(SP30),The requirement of the drawings is 8mm,but it is only 7mm in maximum 6mm in minimum. The following drawings show the detail.

Not enough welding process and excessive grinding.

1. The weld will be grinded flush and cleared.
2. Welding will be performed according to the relevant WPS (WPS-B-T-2132-1).
3. Grinding the weld according to the requirement of approved shop drawing.
4. Perform NDT of the weld according to the shop drawing..
5. Preheat prior to welding to a minimum temperature of 10°C
