Contract #: 04-0120F4Cty: SF/ALA Rte: 80 PM: 13.2/13.9File #: 69.25B**QUALITY ASSURANCE -- NON-CONFORMANCE REPORT****Location:** ZPMC's fabrication shop, Changxing Island, China**Report No:** NCR-000026**Prime Contractor:** American Bridge/Fluor Enterprises, a JV**Date:** 13-Jan-2008**Submitting Contractor:** Zhenhua Port Machinery Company, Ltd (ZPMC), Changxing Island**NCR #:** ZPMC-0025**Type of problem:**

ZPMC damaged the base metal while attempting to repair a non-conforming 3 mm deep undercut on a CJP splice of T-Stiffener SP029-01-002.

Job Name: SAS Superstructure

Welding Repair Report

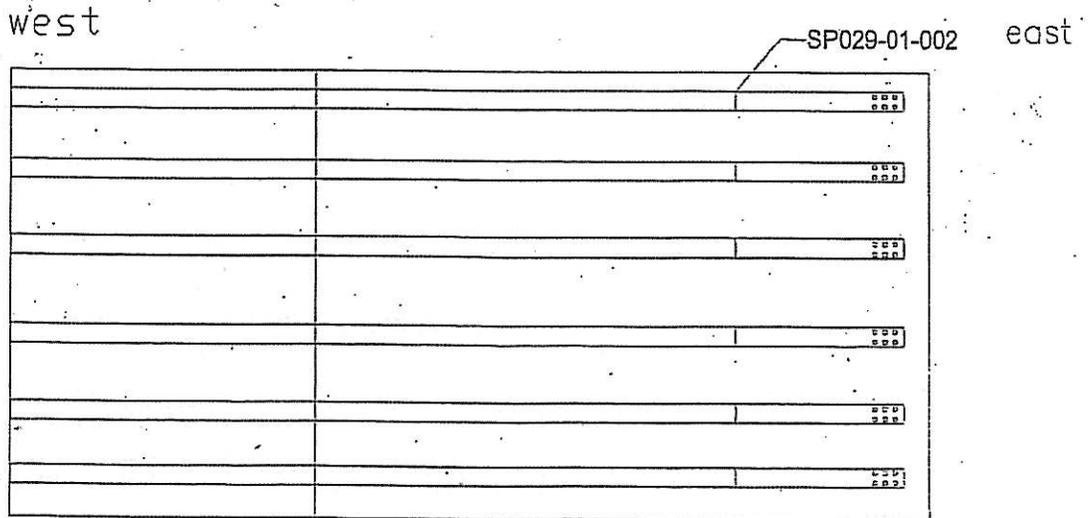
焊缝返修位置示意图:**Draft of welding discontinuity:**

检查发现RS17A/RS8BB两根工字钢对接处咬边3mm, 焊缝编号为SP029-01-002. 具体见下图。

At the welding joint of the two H-ribs RS17A and RS8BB we found one undercut, whose length was 3mm, and the weld number was SP029-01-002. Please see the draft below.

Caused:

1. The welder can not control very well.

1. Remove the undercut area by means of grinding;

2. Preheating and welding according to the relevant repair WPS;

3. Grind the repaired area flush with the weld;

4. Relevant NDT will be performed according to the shop drawings.
