Contract #: 04-0120F4Cty: SF/ALA Rte: 80 PM: 13.2/13.9File #: 69.25B**QUALITY ASSURANCE -- NON-CONFORMANCE REPORT****Location:** Shanghai, China**Report No:** NCR-000036**Prime Contractor:** American Bridge/Fluor Enterprises, a JV**Date:** 20-Jan-2008**Submitting Contractor:** Zhenhua Port Machinery Company, Ltd (ZPMC), Changxing Island**NCR #:** ZPMC-0035**Type of problem:**

Reference Description: The Contractor missed transverse cracks in the start/stop areas during VT inspection of welds on side plate SP-0030.

Job Name: SAS Superstructure

Subject: NCR No. ZPMC-0035

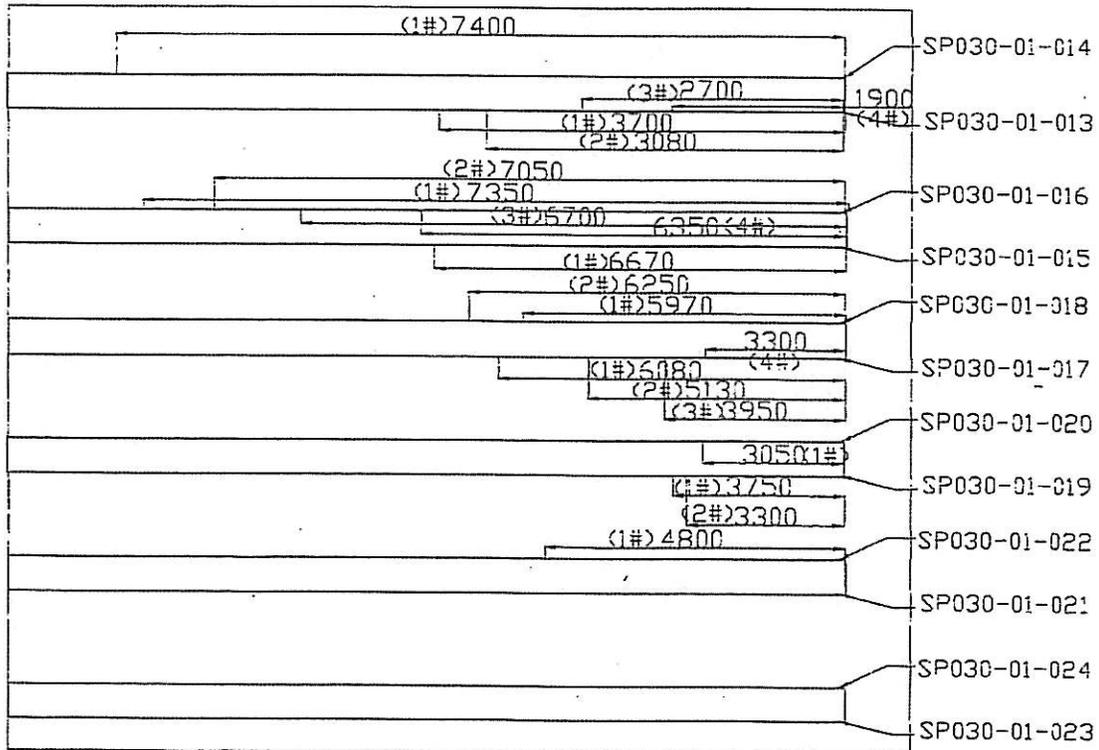
We found several cracks by MT.

因为天气变冷, 冷却速度太快, ZPMC QA/QC已经核实了其它的潜在的可变的因素, 例如: 焊工的技术, WPS的参照参数, 填充金属和焊缝填充的控制, 发现这些变量都服从控制程序和WPS要求。最后, ZPMC使用同样的控制和人员焊接了许多类似的焊缝, 没有发现类似裂纹这样的现象发生, 只到现在天气突然不合季节的变冷。

Since the weather is colder, cooling is faster, ZPMC QA/QC has verified other potential variables such as welder performance, WPS parameters are complied with, weld filler material and weld filler control and found these variables are within compliance of control procedures and WPS requirements.

To date, ZPMC has welded several similar welds using the same controls and personnel, without observing cracking problems similar to these, until recently when the weather has become unseasonably cold.

1. 用打磨或碳刨的方式去除裂纹, 碳刨前预热温度不低于65°C;
2. 焊接前按照焊接返修工艺规程(WPS)准备焊接接头。
3. 作100%MT检查, 确保缺陷完全去除;
4. 按照批准的焊缝返修工艺规程(WPS)进行预热和焊接;
5. 打磨焊缝区域使其与母材或邻近焊缝平齐;
6. 根据图纸要求对修补区域进行检测;

1. Excavate linear indications by means of grinding or gouging. Preheat prior to gouging to a minimum temperature of 65°C.
2. Prepare excavation in accordance with an approved repair WPS prior to welding.
3. Perform MT 100% of the excavation to insure removal of defects. - *Inform CT to verify defects removed prior to performing repair.*
4. Preheat and weld according to the relevant WPS.
5. Following welding grind the weld flush with base metal or contiguous weld.
6. Check the repaired area according to the approved working drawings.

Strengthen preheat interpass temperature and control according to WPS during repairing and work. Measure the pre-heat and interpass temperatures from other plate surfaces to verify heating is uniform throughout the plate thickness.

Pre-heat and interpass temperatures shall cover a larger area to the extent that slower cooling will take place. Thermal blankets shall be used as necessary to control cooling. When electric heat is used, it will be turned down gradually and not turned off immediately after welding.

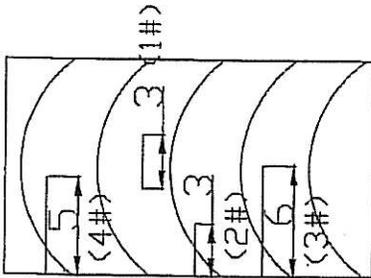
WELD I.D. 焊缝编号	DISCONTINUITY 不连续性			ACCEPT 接受	REJECT 拒收	REMARKS 备注
	INDICATION 指示	TYPE 类型	LENGTH IN mm 长度			
SP030-01-014	1	CRACK	4mm		REJ.	
SP030-01-013	1	CRACK	3mm		REJ.	
	2	CRACK	3mm		REJ.	
	3	CRACK	6mm		REJ.	
	4	CRACK	5mm		REJ.	
SP030-01-016	1	CRACK	6mm		REJ.	
	2	CRACK	3mm		REJ.	
	3	CRACK	4mm		REJ.	
	4	CRACK	5mm		REJ.	
SP030-01-015	1	CRACK	7mm		REJ.	
SP030-01-018	1	CRACK	6mm		REJ.	
	2	CRACK	6mm		REJ.	
SP030-01-017	1	CRACK	6mm		REJ.	
	2	CRACK	3mm		REJ.	
	3	CRACK	4mm		REJ.	
	4	CRACK	4mm		REJ.
