Contract #: 04-0120F4Cty: SF/ALA Rte: 80 PM: 13.2/13.9File #: 69.25B**QUALITY ASSURANCE -- NON-CONFORMANCE REPORT****Location:** Changxing Island, Shanghai, PRC**Report No:** NCR-000056**Prime Contractor:** American Bridge/Fluor Enterprises, a JV**Date:** 06-Jan-2008**Submitting Contractor:** Zhenhua Port Machinery Company, Ltd (ZPMC), Changxing Island**NCR #:** ZPMC-0055**Type of problem:**

**Job Name:** SAS Superstructure

**Subject:** NCR No. ZPMC-0055

Project Name: S.F.O.B.B 项目名称: 美国加州海湾大桥		NCR Number: NCR 编号: NCR-CT-018 / ZPMC
Item: the post-heat treatment problem 名称描述: 后热问题	Item Number: 件号: NA	Drawing: 图号:
Location: 114M Mock Up 位置: 114 米段	Date: 2008-02-26 日期: 2008-02-26

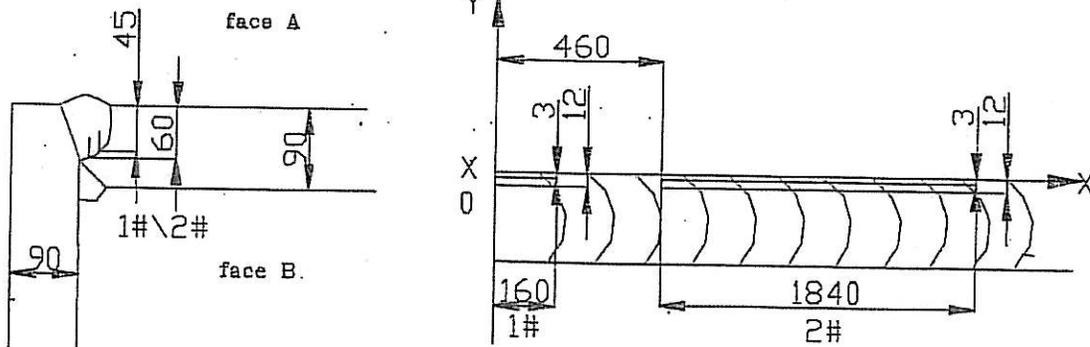
WELD NUMBER: MUC-MA107B/C-2A/2B

缺陷焊缝长度超过检测长度的10%。(MUC-MA107B/C-2A、2B)

Rejectable indication found by ultrasonic inspection exceeds 10% of the weld size.  
(MUC-MA107B/C-2A、2B)

1. 焊工未严格执行WPS相应的规程。
2. 焊道没清理干净。
1. Welder didn't strictly inform relative WPS specification.
2. Did not clear the weld pass completely.

1. Preheat before gouging, the temperature is not below 65°C;
2. Gouge off the defect weld completely, and must prepare a right joint, the joint details should refer to the approved WPS-repair;
3. Grind smoothly the gouged surface;
4. Check with MT or other NDT method to make sure the defect remove completely;
5. Preheat and the interpass temperature control according to the WPS-repair;
6. Postheat after welding, keep the temperature between 230° and 315°C. Deciding how long the postheat time is according to the gouged depth. Usually per 25mm an hour, not less than an hour;
7. Perform NDE in accordance with according to the approved shop drawing.

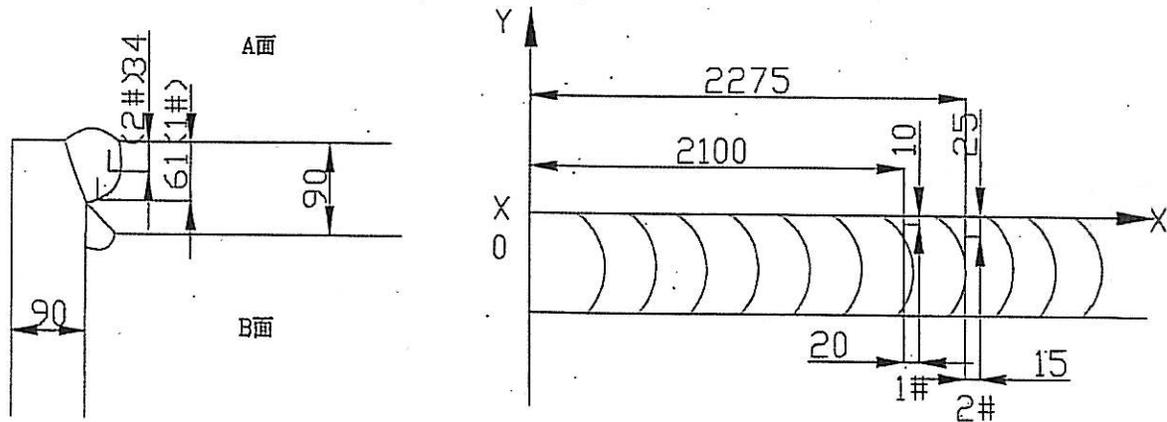
WELD NUMBER: MUC-MA107B/C-2A/2B

Rejected indication found by ultrasonic inspection is less than the maximum allowance aggregate length. (UT探伤发现的缺陷总长度小于最大允许总长度。)MUC-MA107B/C-2A/2B

1. 焊道没清理干净。
1. Did not clear the weld pass completely.

1. Gouge off the defect weld;
2. Grind smoothly the gouged surface;
3. If User's request ,check with MT or other NDT method to make sure the defect remove compelety;
4. Preheat and the interpass temperature control according to the relative WPS-repair;
5. Check the welding according to the approved shop drawing.
