Contract #: 04-0120F4Cty: SF/ALA Rte: 80 PM: 13.2/13.9File #: 69.25B**QUALITY ASSURANCE -- NON-CONFORMANCE REPORT****Location:** Changxing Island, Shanghai, China**Report No:** NCR-000062**Prime Contractor:** American Bridge/Fluor Enterprises, a JV**Date:** 30-Jan-2008**Submitting Contractor:** Zhenhua Port Machinery Company, Ltd (ZPMC), Changxing Island**NCR #:** ZPMC-0060**Type of problem:**

**Job Name:** SAS Superstructure

**QUALITY ASSURANCE -- NON-CONFORMANCE REPORT**

Report No: NCR-000062

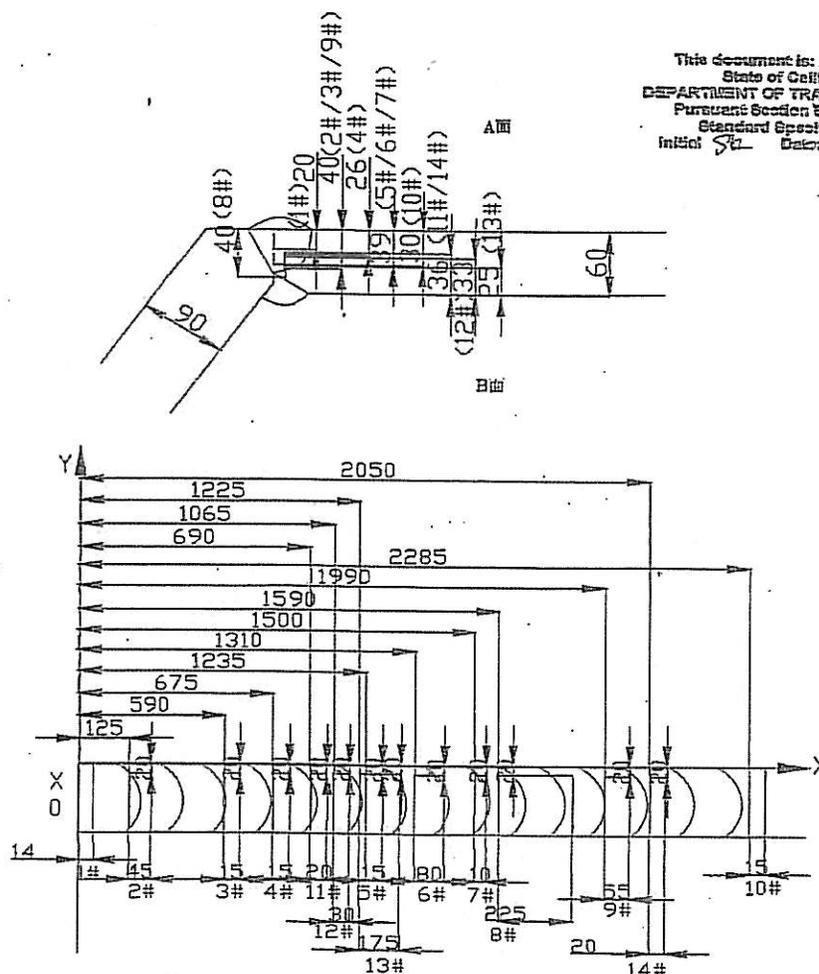
WELD NUMBER: MUC-MA107B/C-4A/4B

Rejectable indication found by ultrasonic inspection exceeds 10% of the weld size.  
(缺陷焊缝长度超过检测长度的10%。)

- 1. 焊工未严格执行WPS相应的规程。
- 2. 焊道没清理干净。
- 1. Welder didn't strictly inform relative WPS specification.
- 2. Did not clear the weld pass completely.

- 1. Preheat before gouging, the temperature is not below 65°C;
- 2. Gouge off the defect weld completely ,and must prepare a right joint ,the joint details should refer to the approved WPS-repair;
- 3. Grind smoothly the gouged surface;
- 4. Check with MT or other NDT method to make sure the defect remove completely;
- 5. Preheat and the interpass temperature control according to the WPS-repair;
- 6. Postheat after welding ,keep the temperature between 230°and 315°C. Deciding how long the postheat time is according to the gouged depth. Usually per 25mm an hour ,not less than an hour;
- 7. Perform NDE in accordance with according to the approved shop drawing.

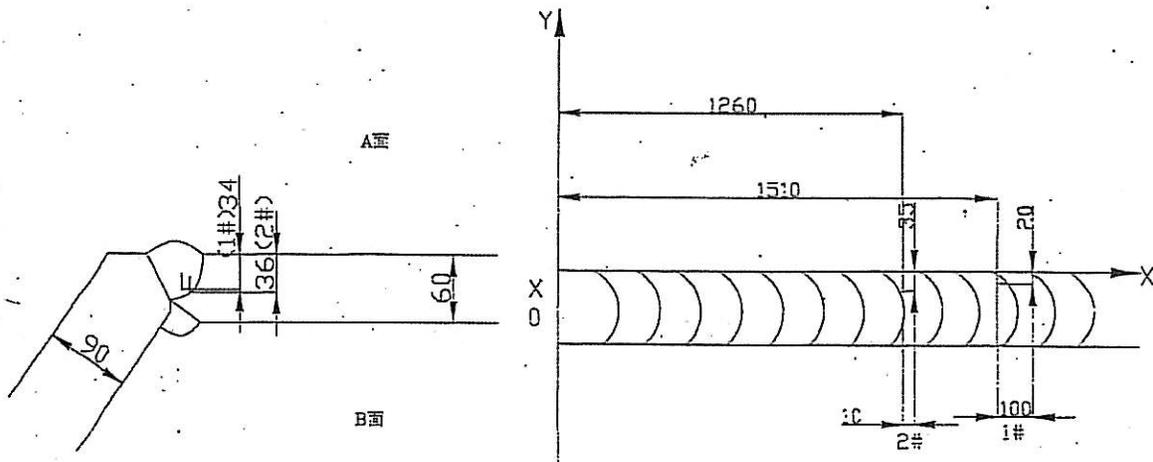
WELD NUMBER: MUC-MA107B/C-4A/4B

Rejected indication found by ultrasonic inspection is less than the maximum allowance aggregate length. (UT探伤发现的缺陷总长度小于最大允许总长度。) MUC-MA107B/C-4A/4B

1. Gouge off the defect weld;
  2. Grind smoothly the gouged surface;
  3. If User's request ,check with MT or other NDT method to make sure the defect remove compelety;
  4. Preheat and the interpass temperature control according to the relative WPS-repair;
  5. Check the welding according to the approved shop drawing.
- 
- 1、 请将有缺陷的焊缝碳刨去除;
  - 2、 将碳刨处打磨光滑;
  - 3、 如用户要求, 用 MT 或其它的无损检测方法证实缺陷被完全清除;
  - 4、 按批准后返修焊接工艺规程 WPS 要求进行预热和控制道间温度;
  - 5、 按图纸要求检测焊缝。

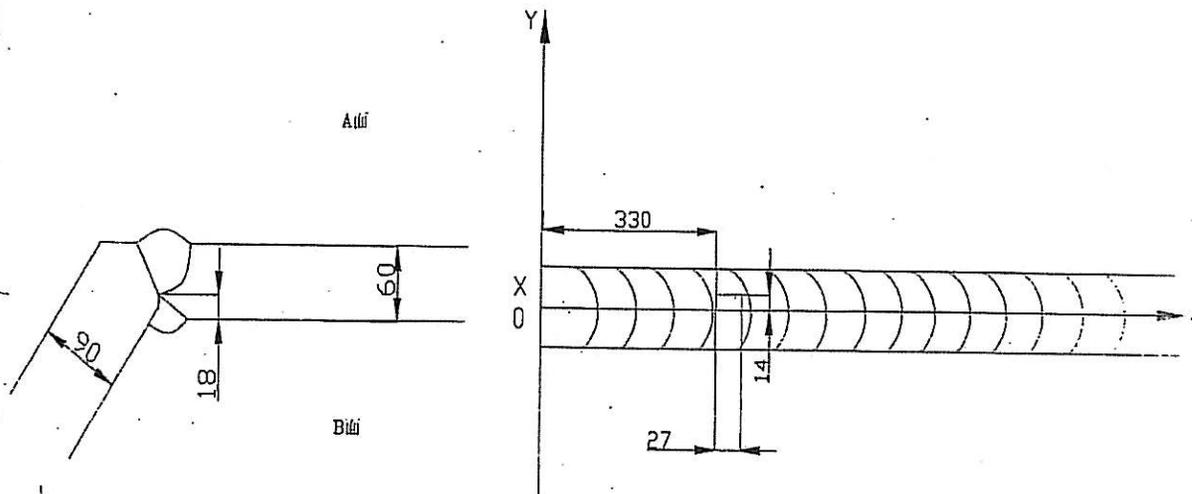
WELD NUMBER: MUC-MA106B/C-4A/4B

Rejected indication found by ultrasonic inspection is less than the maximum allowance aggregate length. (UT探伤发现的缺陷总长度小于最大允许总长度。) MUC-MA106B/C-4A/4B

1. Gouge off the defect weld;
2. Grind smoothly the gouged surface;
3. If User's request ,check with MT or other NDT method to make sure the defect remove completely;
4. Preheat and the interpass temperature control according to the relative WPS-repair;
5. Check the welding according to the approved shop drawing.
