Job Name: SAS Superstructure

QUALITY ASSURANCE -- NON-CONFORMANCE REPORT

Report No: NCR-000069

Welding Concrete Other
 Welding Curing Procedural Bridge No: 34-0006
 Joint fit-up Coating Other Component: DP-058
 Procedural Procedural Descriptor: OBG Deck Panel

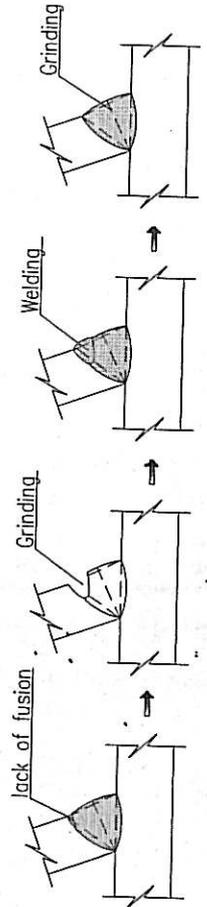
lack of fusion

2.2.2 Lack of fusion will be removed by grinding. MT will be performed to ensure the removal of all defects.

2.2.3 Choose either WPS (WPS-345-FCAW-2G(2F)-repair-1 or WPS-345-SMAW-2G(2F)-repair) to deposit the additional weld metal. Minimum deposit weld size shall follow the corresponding WPS.

2.2.4 Grind flush with the adjacent base metal or weld surface.

2.2.5 Perform MT to the repaired area.

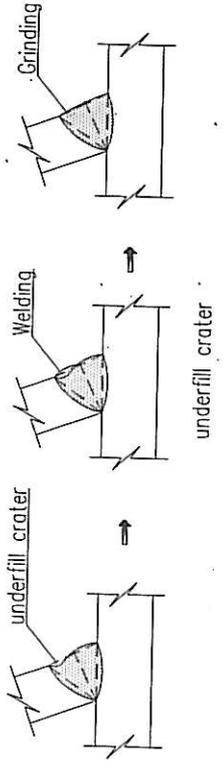
underfill crater

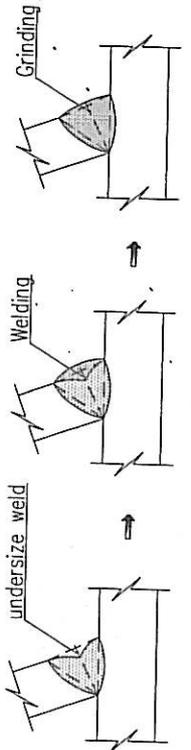
undersize weld

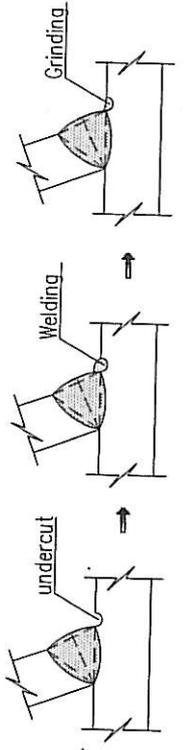
undercut

2.3.1 When undercut values ≤ 0.25 mm, no actions are needed.

2.3.2 When undercut values > 0.25 mm, clear the weld surface to prepare for weld repair, and repair the welds according to step 2.2.
