Contract #: 04-0120F4Cty: SF/ALA Rte: 80 PM: 13.2/13.9File #: 69.25B**QUALITY ASSURANCE -- NON-CONFORMANCE REPORT****Location:** Changxing Island, Shanghai, PRC**Report No:** NCR-000092**Prime Contractor:** American Bridge/Fluor Enterprises, a JV**Date:** 20-Mar-2008**Submitting Contractor:** Zhenhua Port Machinery Company, Ltd (ZPMC), Changxing Island**NCR #:** ZPMC-0090**Type of problem:**

Job Name: SAS Superstructure

Subject: NCR No. ZPMC-0090

Reference Description: Tower Diaphragm 28/38 Meter / Heat Straightening - Active Force Applied

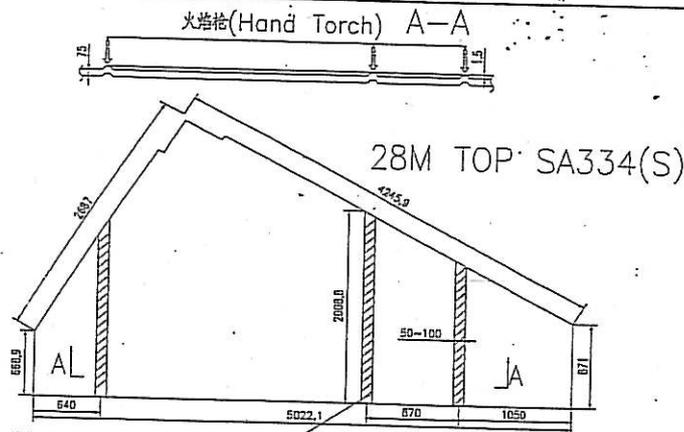
HSR1(T)-0152

Mill induced distortion 钢厂造成的变形

Mill distortion 出厂变形

校火区域: 此板最大变形量约1.5mm

Flame straightening area: the max deformation is about 1.5mm

纵向: 最大校火长度约2008.8mm, 宽度50~100mm

Longitudinal: the max length is about 2008.8mm, the width is 50~100mm

Flame Straightening by natural gas

Production material will be straightened by mechanical means

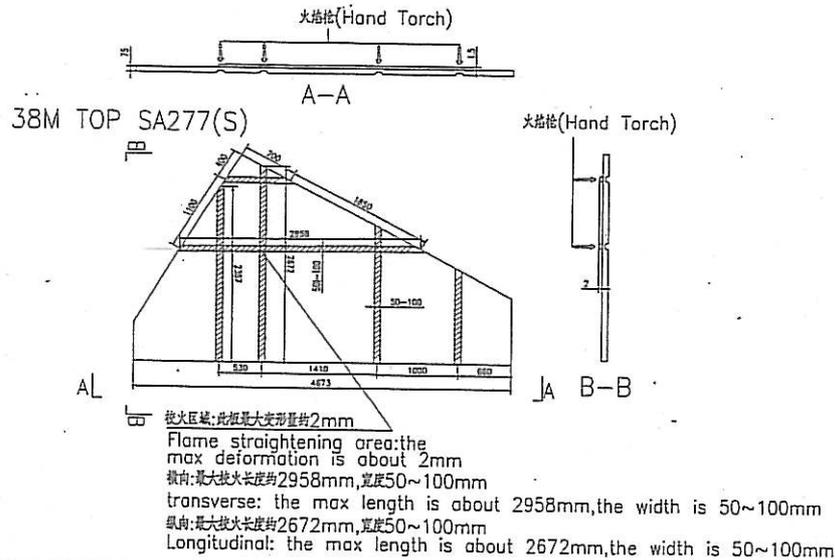
HSR1(T)-188

Cause原因 Mill induced distortion 钢厂造成的变形

Type of Defect缺陷类型 Mill distortion 出厂变形

缺陷去除方法(Defect Removal Method): Flame Straightening by natural gas

纠正措施(Corrective Action(s)): Production material will be straightened by mechanical means
