Contract #: 04-0120F4Cty: SF/ALA Rte: 80 PM: 13.2/13.9File #: 69.25B**QUALITY ASSURANCE -- NON-CONFORMANCE REPORT****Location:** Changxing Island, Shanghai, PRC**Report No:** NCR-000101**Prime Contractor:** American Bridge/Fluor Enterprises, a JV**Date:** 28-Mar-2008**Submitting Contractor:** Zhenhua Port Machinery Company, Ltd (ZPMC), Changxing Island**NCR #:** ZPMC-0099**Type of problem:**

Job Name: SAS Superstructure

Reference Description: Undersized Reinforcement Fillet Weld / 89M Mockup Cross Brace Sub Assembly

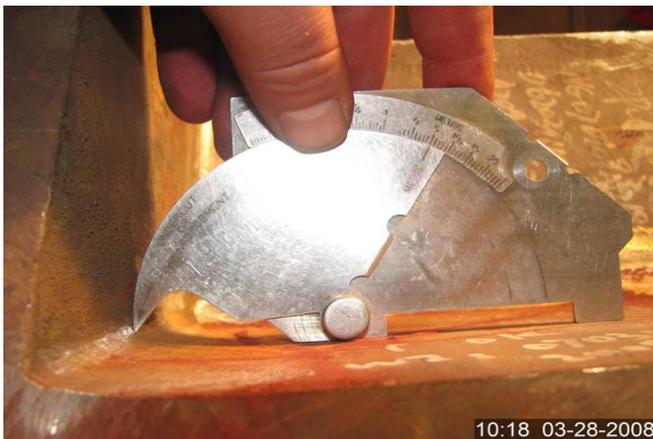
American Bridge/Fluor allowed ZPMC to visually accept and perform magnetic particle inspection on partial joint penetration weld MUSB-MA29-4 despite the insufficient size of the reinforcement fillet weld. The Quality Assurance Inspector measured the reinforcing fillet weld to be approximately 5 millimeters. Per AWS D1.5 2002 the minimum fillet weld required is 8.5 millimeters for the 35 millimeter thickness plate.

AWS D1.5 2002 Figure 2.5 note 6. "Groove welds in corner and T-joints shall be reinforced with fillet welds with a leg size equal to or greater than T/4, but need not exceed 10 mm [3/8 in.]."

Insufficient size of the reinforcement fillet weld and failure of Quality Control inspection to identify the deficiency. See attached NCR No: ZPMC-0099 for details.

Reference Resolution: The Special Provisions do not require a reinforcement fillet weld on a Tower PJP weld.

Page 321 of Special Provisions Section 10-1.59 states that fillet reinforcement required by Note 6 of Figures 2.4 and 2.5 of AWS D1.5 will not be required for PJP welds in the tower.

Special Provisions Section 10-1.59 states that fillet reinforcement required by Note 6 of Figures 2.4 and 2.5 of AWS D1.5 will not be required for PJP welds in the tower.
