Contract #: 04-0120F4Cty: SF/ALA Rte: 80 PM: 13.2/13.9File #: 69.25B**QUALITY ASSURANCE -- NON-CONFORMANCE REPORT****Location:** Changxing Island, Shanghai, PRC**Report No:** NCR-000104**Prime Contractor:** American Bridge/Fluor Enterprises, a JV**Date:** 28-Mar-2008**Submitting Contractor:** Zhenhua Port Machinery Company, Ltd (ZPMC), Changxing Island**NCR #:** ZPMC-0101**Type of problem:**

**Job Name:** SAS Superstructure

**Subject:** NCR No. ZPMC-0101

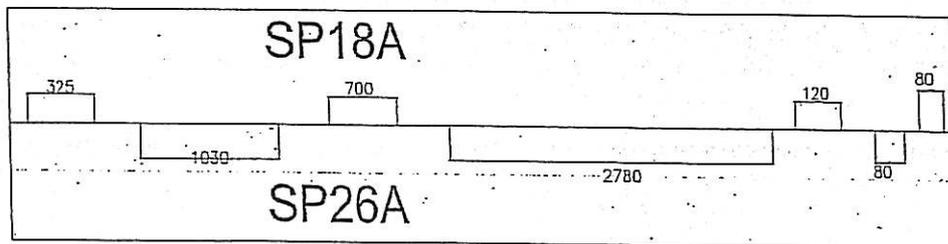
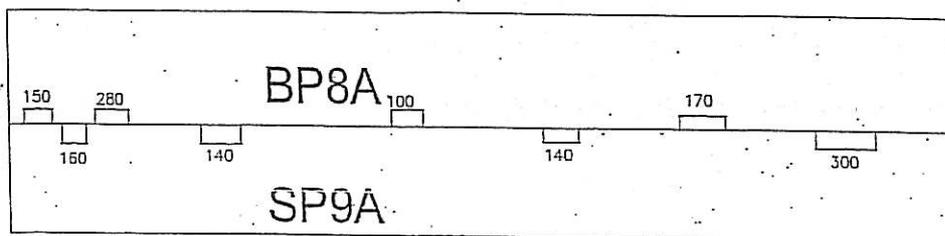
SP18A与SP26A、BP8A与BP9A两拼装配间隙超标, 最大间隙为10.6mm.

During assembling the SP18A and SP26A, BP8A and BP9A, the gap exceeds the maximum allowance; the maximum gap is about 10.6mm.

因施工队在修割余量时没有严格控制好尺寸。

Worker failed in controlling the dimension when cutting the allowance.

1. 将尺寸超差部位清洁并打磨使与周边母材平滑过渡;
  2. 根据相应的修补WPS在陶瓷衬垫上对超差区域进行堆焊处理;
  3. 补焊区域打磨至要求的根部间隙;
  4. 对补焊区域进行100%MT及UT检查。
1. Clean the out-of-tolerance area and grind flush to the adjacent base metal.
  2. Welding will be performed of this area on the ceramic backing according to relevant repair WPS.
  3. Grind the repaired area to the requirements of root gap.
  4. Perform 100% MT and UT of this area.
