## QUALITY ASSURANCE -- NON-CONFORMANCE REPORT

**Report No:** NCR-000107

**NCR #:** ZPMC-0104

**Job Name:** SAS Superstructure

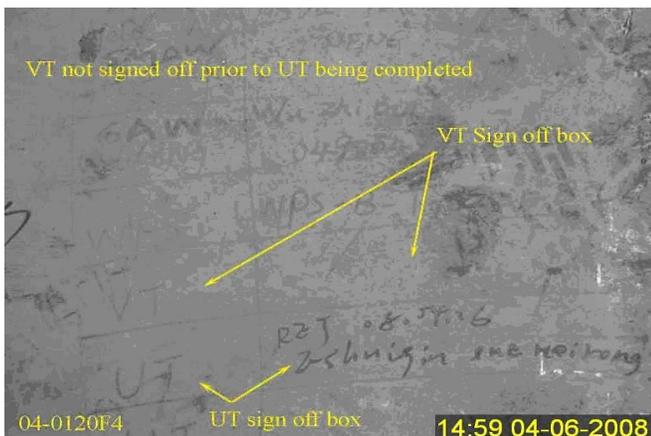
A ZPMC Quality Control (QC) Inspector, Eshui Qin, was observed using unapproved procedures while performing Ultrasonic Testing on the on Complete Joint Penetration (CJP) Internal Tower Diaphragm splice weld number ESD1-SA234-A/B-10A. During the UT inspection high amplitude ultrasonic signals were observed when scanning the weld toe areas. The QA inspector observed that the UT signals were "finger dampened" in order to decrease the amplitude of the signals, this technique is not allowed by the Special Provisions.

It should be noted that when QC Inspector Eshui Qin went to mark on the plate, the UT inspection had been performed but the visual inspection had not been marked as being completed prior to the UT inspection. The QC Inspector did not appear to be aware of the status of the visual inspection. A table marked on the plate by ZPMC that is to be used for marking the status of inspections was not marked prior to the UT Inspector. See digital photo below.

ZPMC has been informed that the Contract does not allow finger damping as a means of acceptance. All welds exceeding the reference levels and or requirements of the Contract shall be repaired. NOTE: AWS D1.5 does not address performing visual inspection prior to ultrasonic inspection as suggested in this NCR.

The proposed resolution is acceptable. Each of the finger dampened areas was re-inspected, and finger dampening during Ultrasonic Testing has no longer been an issue. The Department concurs that Non-Conformance ZPMC-0104 is closed.
