Contract #: 04-0120F4Cty: SF/ALA Rte: 80 PM: 13.2/13.9File #: 69.25B**QUALITY ASSURANCE -- NON-CONFORMANCE REPORT****Location:** Changxing Island, Shanghai, PRC**Report No:** NCR-000119**Prime Contractor:** American Bridge/Fluor Enterprises, a JV**Date:** 17-Apr-2008**Submitting Contractor:** Zhenhua Port Machinery Company, Ltd (ZPMC), Changxing Island**NCR #:** ZPMC-0115**Type of problem:**

Job Name: SAS Superstructure

Subject: NCR No. ZPMC-0115

Welding Repair Report

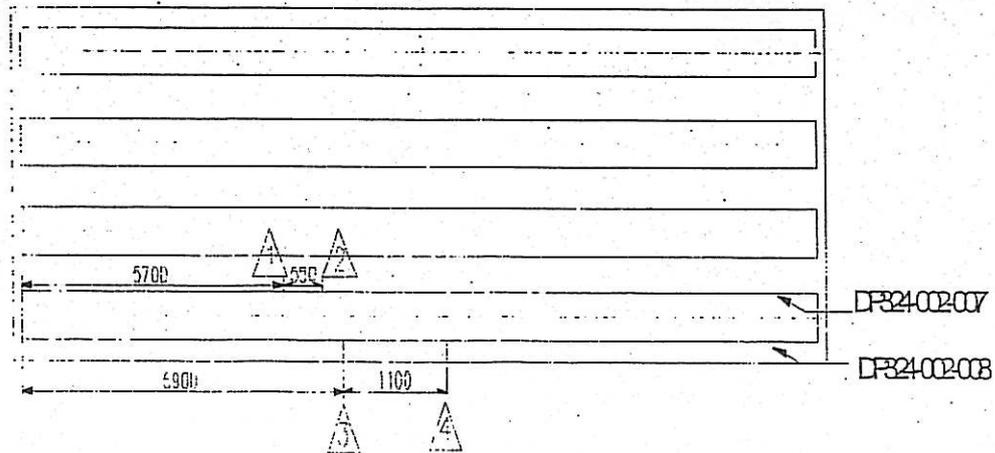
Draft of welding discontinuity:

3A-5A-E 图号DP324/PL371B 的U肋顶板在点焊装配后经目检发现多处点焊裂纹。打磨清除干净后,其中4处顶板母材损伤(长度为90mm,最深处为5mm)。具体位置见下图。

There were many cracks in the tack welding after assembling, the base material (DP324/PL371B) was gouged after grinding, the length is 90mm, the depth is 5mm, the following shows the detail position.

- 1.板单元装配前未清理干净导致定位焊出现裂纹,压制反变形受外力影响定位焊裂纹延伸至母材
1.It didn't clear completely before assembly, which leded the cracks in the tack welding, when it pressed the anti-deformation, the crack extended into the base material.

1. 焊接前按照焊接返修工艺规程(WPS)准备焊缝接头型式;
 2. 作100%MT检查, 确保缺陷完全去除;
 3. 按照批准的焊缝返修工艺规程(WPS)进行预热和焊接;
 4. 打磨焊缝区域使其与母材平齐;
 5. 对修补区域作100%MT及检测;
 6. 按照图纸要求重新进行定位焊接。
-
1. Prepare excavation in accordance with an approved repair WPS prior to welding.
 2. Perform MT 100% of the excavation to insure removal of defects.
 3. Preheat and weld according to the relevant repair WPS.
 4. Following welding grind the weld flush with base metal.
 5. Perform MT 100% of repaired area.
 6. Tack weld according to the working drawings.

1. Clear the panel before assembly and improve monitoring welding quality.
