Contract #: 04-0120F4Cty: SF/ALA Rte: 80 PM: 13.2/13.9File #: 69.25B**QUALITY ASSURANCE -- NON-CONFORMANCE REPORT****Location:** Changxing Island, Shanghai, PRC**Report No:** NCR-000122**Prime Contractor:** American Bridge/Fluor Enterprises, a JV**Date:** 18-Apr-2008**Submitting Contractor:** Zhenhua Port Machinery Company, Ltd (ZPMC), Changxing Island**NCR #:** ZPMC-0118**Type of problem:**

QUALITY ASSURANCE -- NON-CONFORMANCE REPORT

NON-CONFORMANCE REPORT TRANSMITTAL

Subject: NCR No. ZPMC-0118

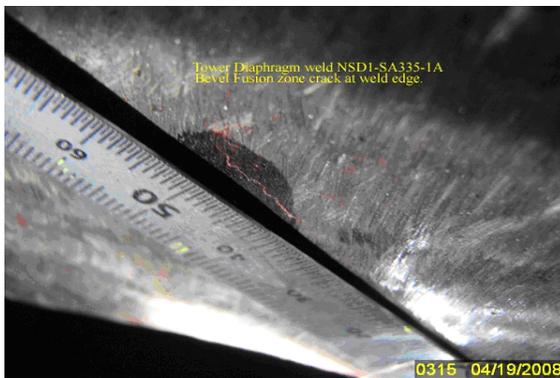
ABF has allowed ZPMC QC to accept a Complete Joint Penetration weld with a crack on weld # NSD1-SA335-1, plate SA335 to P459. ZPMC QC Inspector MR. Botin Rui accepted the weld on April 18, 2008. Caltrans QA Inspector Viars retested the weld by MT and found a 15 mm crack on the weld groove bevel in the base metal near the weld metal. Applicable reference which has been violated includes American Welding Society AWS D1.5 (2002) section 6.26.2 which states "Welds that are subject to RT or MT in addition to visual inspection shall have no cracks and shall be unacceptable if the RT or MT shows any types of discontinuities described in 6.26.2.1, 6.26.2.2, 6.26.2.3, or 6.26.2.4"

American Welding Society AWS D1.5 (2002) section 6.26.2 which states "Welds that are subject to RT or MT in addition to visual inspection shall have no cracks."

- Propose a resolution for the identified non-conformance with revised procedures to prevent future occurrences.
- Submit a critical weld repair for the crack found for engineer's approval prior to the repair.

ZPMC acknowledged this problem and did the MT again. The ZPMC inspector found the linear indication was on the surface of the butt weld edge, so the defect was removed after a little bit grinding. UT report T787-UT-463 and MT report T787-MT-833 showed this weld had been accepted, and this double diaphragm has been finally tagged after CT's inspection. ZPMC had also given a verbal warning that the NDT technician must keep a close eye against losing the small defect when he did the MT.
