## QUALITY ASSURANCE -- NON-CONFORMANCE REPORT

**Report No:** NCR-000127

**NCR #:** ZPMC-0121

**Reference Description:** ABF-SUB-000634R01, "Repair Procedure for Closed-Rib Welds"

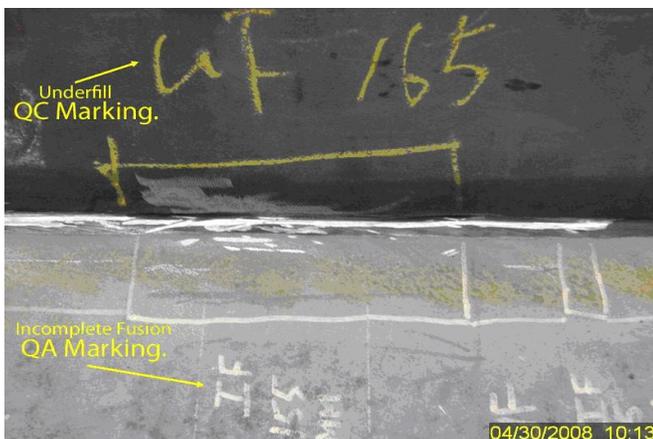
The Contractor did not perform weld repairs in accordance with accepted procedures. The Contractor performed repairs to lack of fusion in a closed rib weld without performing MT after grinding to ensure the removal of all defects. When informed of this, the Contractor stated that the repair was being performed for underfill, not for lack of fusion. The accepted closed rib weld repair procedures do not allow grinding prior to welding for underfill repair. This occurred on weld joint #008 of deck panel DP-021-002.

**Reference Resolution:** ZPMC will check surface condition and mark defect by specification code and will consider the view of ABF and CT when correcting defects.

DP-018-002 was repaired and inspected by gate to gate UT and PAUT. The repair was accepted as indicated by NDT. The panel is accepted with an ABF Green Tag.

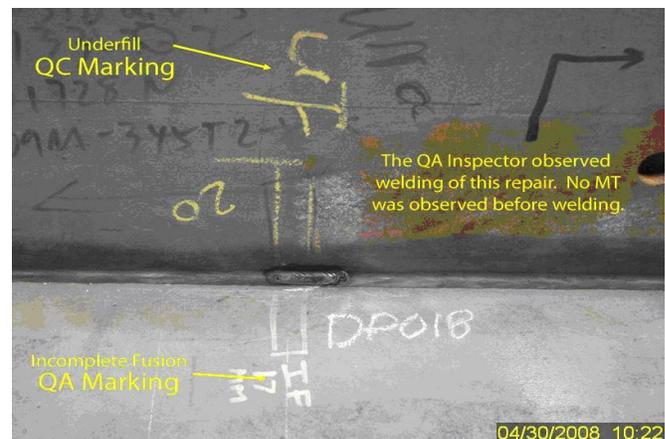
It was also observed that the Contractor has performed grinding in preparation for weld repairs on other defects which the Contractor has classified as underfill. This was observed in weld #007 of deck panel DP-018-002.
