Contract #: 04-0120F4
 Cty: SF/ALA Rte: 80 PM: 13.2/13.9
 File #: 69.25B

QUALITY ASSURANCE -- NON-CONFORMANCE REPORT

Report No: NCR-000128

Welding	Concrete	Other	
Welding	Curing	Procedural	Bridge No: 34-0006
Joint fit-up	Coating	Other	Component: Changxing Island, Shanghai, PRC
Procedural	Procedural	Descriptor: OBG Deck Panel

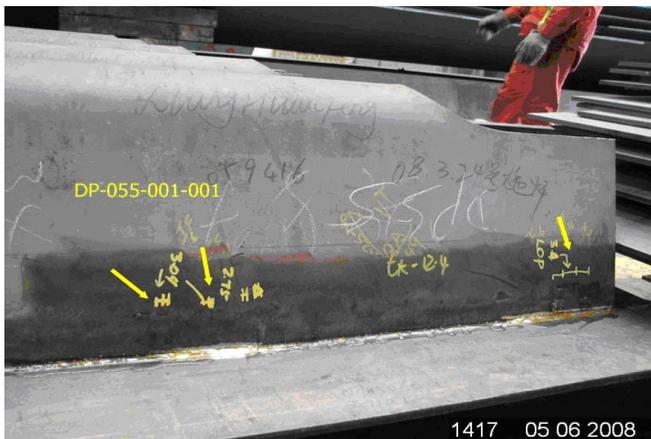
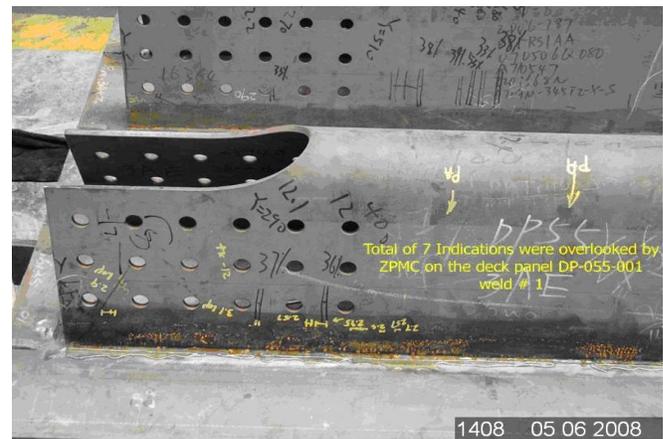
The Contractor missed rejectable indications while performing UT. The Contractor did not identify areas of closed rib to box shell plate partial joint penetration (PJP) groove welds that have a depth of penetration less than 80% of the rib thickness. There are seven (7) areas on deck panel DP-055-001 that have an accumulative length of 131mm that have depth of penetration of less than 80%. This occurred on weld joint #001 of DP-055-001.

"Welding of closed ribs to box shell plates shall be accomplished with a welding process and procedure that achieves a minimum of 80% penetration of the nominal rib thickness."

At the time of this NCR, ZPMC was interpreting the specifications to mean any Depth of Penetration less than 70% is unacceptable. Since this time there has been several meetings with ZPMC to discuss the acceptance criteria relative to UT on the deck panels and the criteria is now understood.
