Contract #: 04-0120F4  
 Cty: SF/ALA Rte: 80 PM: 13.2/13.9  
 File #: 69.25B

## QUALITY ASSURANCE -- NON-CONFORMANCE REPORT

**Report No:** NCR-000130

**Reference Description:** Repairs to Base Metal

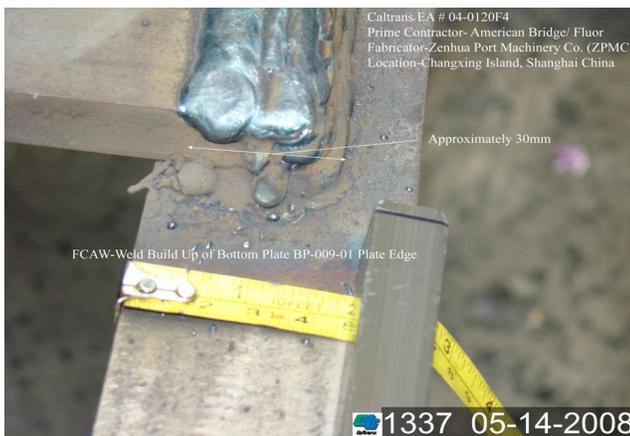
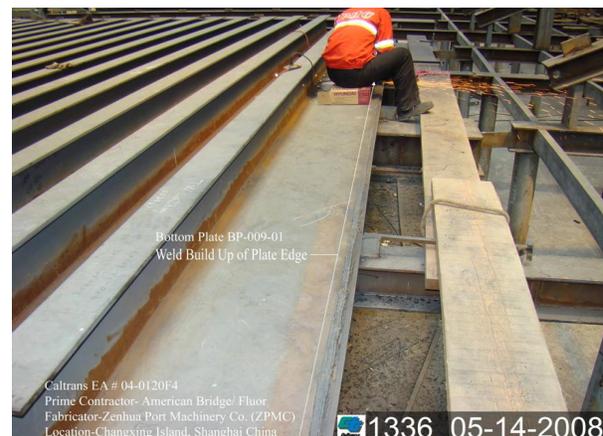
The Contractor performed base metal repair without prior Engineer approval. The Contractor was observed depositing additional weld metal to (buttering) the edge of plate BP9A in order to correct insufficient plate width. It was observed that approximately 30mm of built-up weld metal extends from the plate edge along the full length of the plate. This occurred on bottom panel BP-009-01 of segment assembly SEG-015A.

AWS D1.5, Section 3.7.4: "Prior approval of the Engineer shall be obtained for repairs to base metal...."

Propose a resolution for the identified non-conformance to prevent future occurrences.

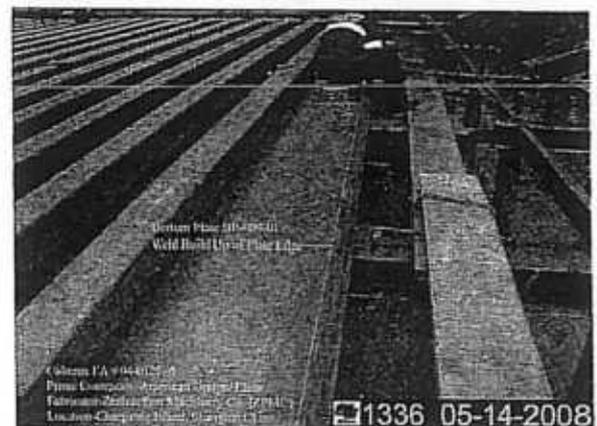
The Contractor performed base metal repair without prior Engineer approval. The Contractor was observed depositing additional weld metal to (buttering) the edge of plate BP9A in order to correct insufficient plate width. It was observed that approximately 30mm of built-up weld metal extends from the plate edge along the full length of the plate. This occurred on bottom panel BP-009-01 of segment assembly SEG-015A.

AWS D1.5, Section 3.7.4: "Prior approval of the Engineer shall be obtained for repairs to base metal...."

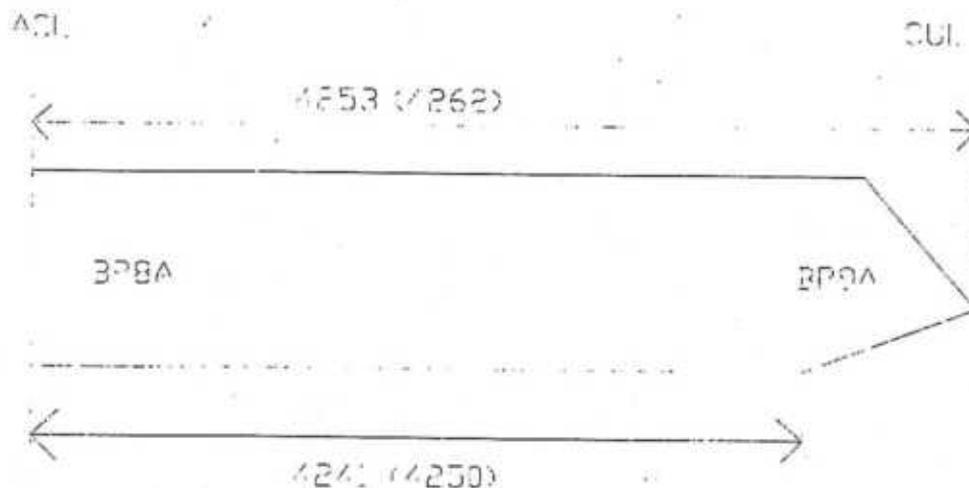
**Draft of welding discontinuity:**

由于切割工粗心大意导致余量切割错误。

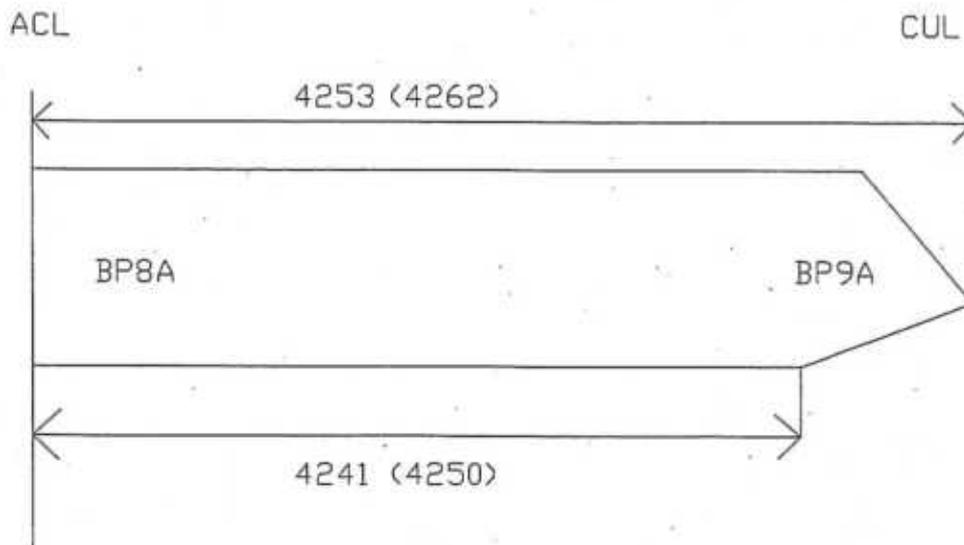
When fabrication West 3B segment type D6 bottom BP9A, per error cutting, it should be 4250mm and 4260mm from Assembly Control Line (ACL) to Cut Line (CUL), but it is only 4241mm and 4253mm.

由于切割工粗心大意导致余量切割错误。

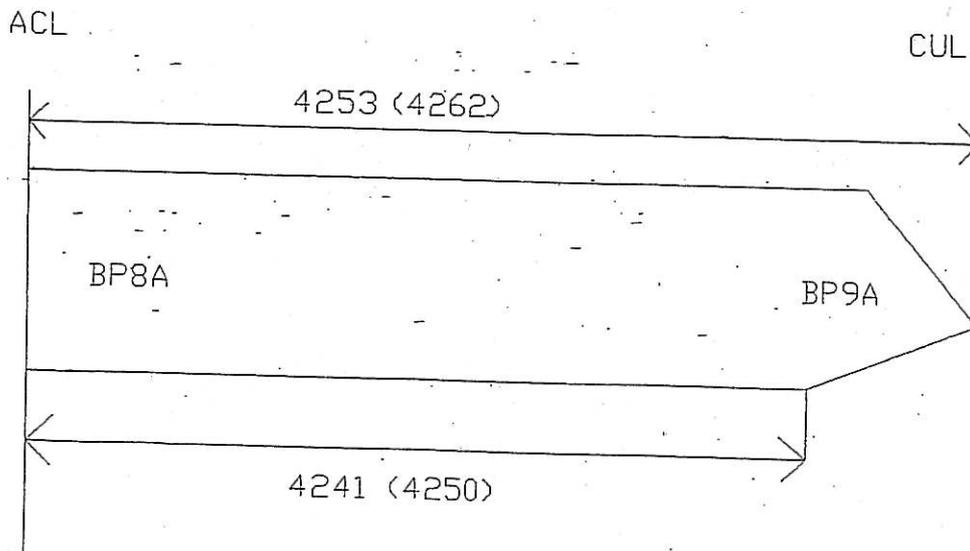
#### Draft of welding discontinuity:

由于切割工粗心大意导致余量切割错误。
