Contract #: 04-0120F4Cty: SF/ALA Rte: 80 PM: 13.2/13.9File #: 69.25B**QUALITY ASSURANCE -- NON-CONFORMANCE REPORT****Location:** Changxing Island, Shanghai, PRC**Report No:** NCR-000133**Prime Contractor:** American Bridge/Fluor Enterprises, a JV**Date:** 14-May-2008**Submitting Contractor:** Zhenhua Port Machinery Company, Ltd (ZPMC), Changxing Island**NCR #:** ZPMC-0127**Type of problem:**

Job Name: SAS Superstructure

Subject: NCR No. ZPMC-0127

Project Name: 项目名称: S.F.O.B.B 美国加州海湾大桥	NCR Number: NCR-000133 (ZPMC-0127) NCR 编号: NCR-B-059
Item: unacceptable weld surface profiles 名称描述: 不可接受的焊缝表面状况	Item Number: 件号:
Location: OBG repair shop 位置: 桥面返修车间	Drawing Number: 图号: DP-060-001
Date: 日期: 2008-5-14

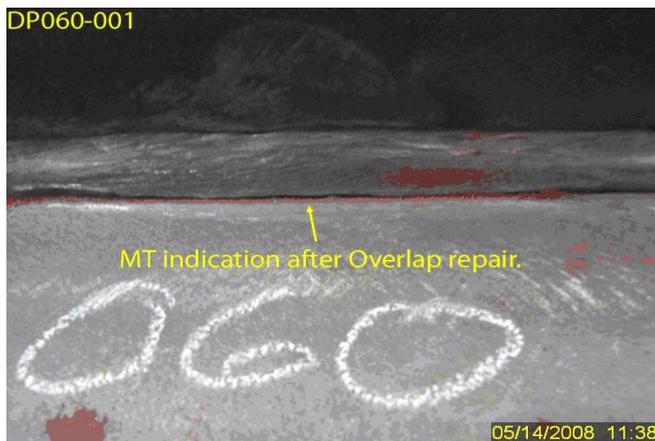
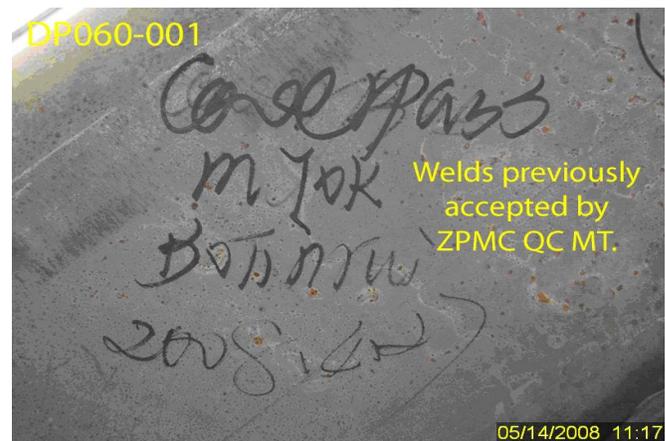
The Contractor accepted weld repairs that resulted in unacceptable weld surface profiles. During QA magnetic particle testing of closed rib to box shell plate weld repairs, multiple indications were observed at the toe of welds that had previously been found acceptable by the Contractor. This occurred on repairs to deck panel DP-060-001.

The grinding of overlap was insufficient so as to hold powder during magnetic particle inspection. The grinding technique has been further refined to prevent this indication and the MT inspectors have been informed of what they thought was considered a non relevant indication due to change in geometry at the transition between deck to rib to identify this indication as a remnant of the overlap being removed.

表面焊缝形状导致伪缺陷产生。
 预防措施 The weld's surface shape caused the fake defects.
 加强打磨。
 Enhance grinding. Approved by/批准: Li Liming 2008.06.03

Reference Resolution: The grinding technique has been further refined to prevent this indication and the MT inspectors have been retrained.

The proposed resolution is acceptable. Submittal ABF-SUB-634R06 includes procedures for correcting overlap on the closed rib welds, and the welds in question were accepted as shown on the attached NDT reports. The Department concurs that Non-Conformance ZPMC-0127 is closed.

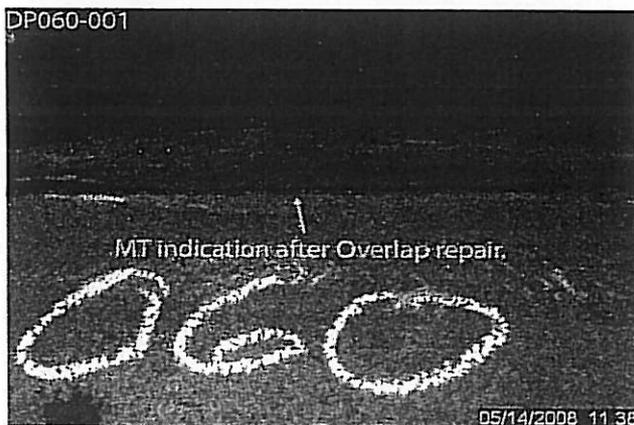
The Contractor accepted weld repairs that resulted in unacceptable weld surface profiles. During QA magnetic particle testing of closed rib to box shell plate weld repairs, multiple indications were observed at the toe of welds that had previously been found acceptable by the Contractor. This occurred on repairs to deck panel DP-060-001.

The Contractor provided VT and MT reports after cover pass; submittal 634R06 addressed cover pass repair procedures. Although this does not correct the systemic problem, METS was directed by Team China Construction to close the NCR.

Closed by Caltrans Construction. METS closed the NCR based on Construction's direction.
