**DEPARTMENT OF TRANSPORTATION**

Contract #: 04-0120F4Cty: SF/ALA Rte: 80 PM: 13.2/13.9File #: 69.25B**QUALITY ASSURANCE -- NON-CONFORMANCE REPORT****Location:** Changxing Island, Shanghai, PRC**Report No:** NCR-000134**Prime Contractor:** American Bridge/Fluor Enterprises, a JV**Date:** 14-May-2008**Submitting Contractor:** Zhenhua Port Machinery Company, Ltd (ZPMC), Changxing Island**NCR #:** ZPMC-0128**Type of problem:**

## NON-CONFORMANCE REPORT TRANSMITTAL

**Job Name:** SAS Superstructure

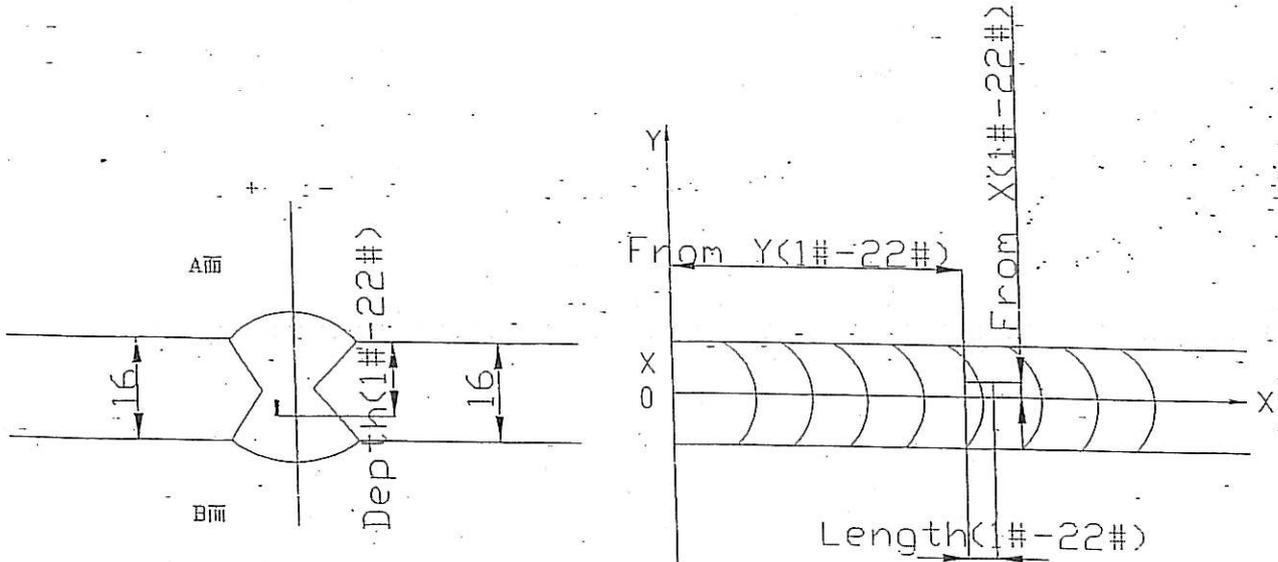
WELD NUMBER: SEG013A-007

Rejected indication found by ultrasonic inspection is less than the maximum allowance aggregate length.

(UT探伤发现的缺陷总长度小于最大允许长度。) SEG013A-007

Please see the detail data from UT report!

1. 从B面采用碳刨或打磨的方法去除焊缝缺陷，碳刨之前必须进行预热，温度不低于65°C;
  2. 准备正确的接头型式，具体参照返修焊接工艺规程 (WPS);
  3. 采用MT或其它无损检测方法保证缺陷完全被清除;
  4. 预热及焊接要求参照已批准的返修焊接工艺规程 (WPS) 执行;
  5. 将修补区域打磨到与母材或邻近焊缝平齐;
  6. 根据批准的车间图纸检查焊缝.
- 
1. Gouge or grind to remove all the defects from the Face B. Preheat prior to gouging to a minimum temperature of 65°C;
  2. Prepare excavation according to the approved repair WPS;
  3. Perform MT or other NDT methods of the area to insure the removal of the defects;
  4. Preheat and weld according to the relevant repair WPS;
  5. Grind the repaired area flush with base metal or the adjacent weld;
  6. Check the welds according to the working drawings.

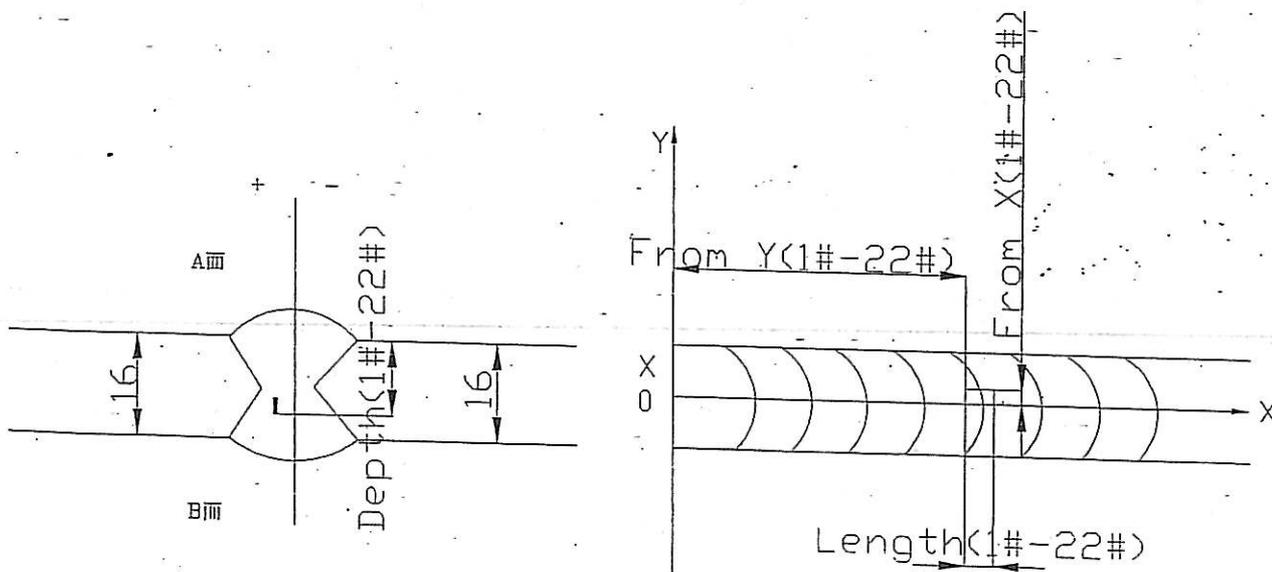
WELD NUMBER: SEG013A-007

Rejected indication found by ultrasonic inspection is less than the maximum allowance aggregate length.

(UT探伤发现的缺陷总长度小于最大允许长度。) SEG013A-007

Please see the detail data from UT report!

1. 从B面采用碳刨或打磨的方法去除焊缝缺陷，碳刨之前必须进行预热，温度不低于65℃；
2. 准备正确的接头型式，具体参照返修焊接工艺规程（WPS）；
3. 采用MT或其它无损检测方法保证缺陷完全被清除；
4. 预热及焊接要求参照已批准的返修焊接工艺规程（WPS）执行；
5. 将修补区域打磨到与母材或邻近焊缝平齐；
6. 根据批准的车间图纸检查焊缝。

1. Gouge or grind to remove all the defects from the Face B. Preheat prior to gouging to a minimum temperature of 65°C;
2. Prepare excavation according to the approved repair WPS;
3. Perform MT or other NDT methods of the area to insure the removal of the defects;
4. Preheat and weld according to the relevant repair WPS;
5. Grind the repaired area flush with base metal or the adjacent weld;
6. Check the welds according to the working drawings.
