Contract #: 04-0120F4Cty: SF/ALA Rte: 80 PM: 13.2/13.9File #: 69.25B**QUALITY ASSURANCE -- NON-CONFORMANCE REPORT****Location:** Changxing Island, Shanghai, PRC**Report No:** NCR-000136**Prime Contractor:** American Bridge/Fluor Enterprises, a JV**Date:** 16-May-2008**Submitting Contractor:** Zhenhua Port Machinery Company, Ltd (ZPMC), Changxing Island**NCR #:** ZPMC-0130**Type of problem:****Welding****Concrete****Other****Welding****Curing****Procedural****Bridge No:** 34-0006**Joint fit-up****Coating****Other****Component:** FB012-011/FB011-006/FB016-006/FB016-008/FB016-**Procedural****Procedural****Descriptor:** OBG Floorbeams**Reference Description:** Did not correct welds with questionable test results**Description of Non-Conformance:**

Job Name: SAS Superstructure

Subject: NCR No. ZPMC-0130

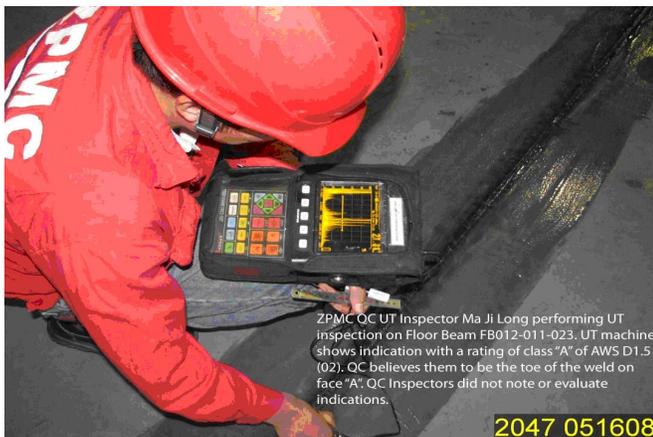
The Contractor did not correct welds whose surface profiles produced questionable test results. The Contractor's QC ignored Class A indications found during the performance of UT. The Contractor's QC stated that the indications were disregarded because they believe the indications to be from the toe of the weld. The Contractor did not grind the weld smooth and did not blend the weld with adjacent material prior to performing UT. This occurred on weld joint #s FB012-011-023, FB011-006-021, FB016-006-021, FB016-008-021, and FB016-013-021.

Special Provisions, Section 8-3.01 Welding: "Groove weld surface profiles that interfere with the performance of the NDT procedure or produce questionable test results shall be ground smooth and blended with the adjacent material.... Questionable test results are defined as test results containing relevant or non-relevant indications or results from a situation where a defect may have been masked by the weld profile. Finger dampening the ultra-sonic (UT) signal shall not be considered resolution of questionable test results."

ZPMC UT operators have been instructed that finger dampening cannot be used as a means of acceptance and if exceeding the reference level of inspection must be marked for repair. Repair is to be performed as necessary until acceptable results are achieved.

ZPMC performed weld repair on joints FB012-011-023, FB011-006-021, FB016-006-021, FB016-008-021, and FB016-013-021. NDT results indicated that the welds are acceptable. This corrective action is acceptable.
