Contract #: 04-0120F4Cty: SF/ALA Rte: 80 PM: 13.2/13.9File #: 69.25B**QUALITY ASSURANCE -- NON-CONFORMANCE REPORT****Location:** Changxing Island, Shanghai, PRC**Report No:** NCR-000137**Prime Contractor:** American Bridge/Fluor Enterprises, a JV**Date:** 21-May-2008**Submitting Contractor:** Zhenhua Port Machinery Company, Ltd (ZPMC), Changxing Island**NCR #:** ZPMC-0131**Type of problem:**

**Reference Description:** Unapproved repair of cracked tack welds**Description of Non-Conformance:**

**Job Name:** SAS Superstructure

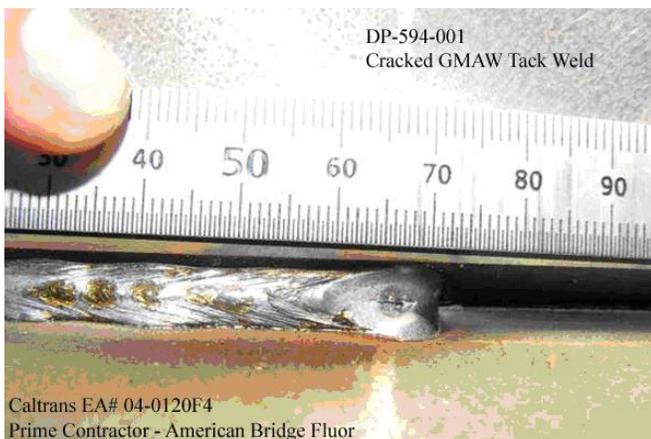
The Contractor did not properly evaluate the extent of a crack prior to repair and welding over the crack. The Contractor attempted to repair numerous cracked tack welds by grinding without performing MT, PT or other equally positive means to ascertain the extent of the cracks. The Contractor did not remove 50 millimeters on either side of the crack before commencing the closed rib GMAW root pass. This occurred on tack welds in weld joint #s -001 through -010 on deck panel DP-594-001. The cracks were initially observed on Tuesday 05-20-2008 as indicated in the time and date stamp in the digital photograph below.

AWS D1.5, Section 3.7.2.4: "Cracks in Weld or Base Metal. The extent of the crack shall be ascertained by use of MT, PT, or other equally positive means; the metal shall be removed for the full length of the crack plus 50 mm [2 in.] beyond each end of the crack, and rewelded."

The Contractor did not properly evaluate the extent of a crack prior to repair and welding over the crack. The Contractor attempted to repair numerous cracked tack welds by grinding without performing MT, PT or other equally positive means to ascertain the extent of the cracks. The Contractor did not remove 50 millimeters on either side of the crack before commencing the closed rib GMAW root pass. This occurred on tack welds in weld joint #s -001 through -010 on deck panel DP-594-001.

**Reference Resolution:** ZPMC is now performing NDT on all tacks as an initial means of inspection to complement the VT inspection.

If cracks are determined to be in the tack locations of finished welds, they will be removed to the extent directed by the Engineer, repaired by welding per the approved internal weld repair procedure and re-inspected using the same modified UT method as originally used to determine the existence of the crack.

The Contractor is now performing NDT on all tacks as an initial means of inspection to complement the VT inspection. CT is performing modified UT testing of all tack weld locations in finished deck panels to verify if cracks remain after completion of welding.
