Contract #: 04-0120F4Cty: SF/ALA Rte: 80 PM: 13.2/13.9File #: 69.25B**QUALITY ASSURANCE -- NON-CONFORMANCE REPORT****Location:** Changxing Island, Shanghai, PRC**Report No:** NCR-000138**Prime Contractor:** American Bridge/Fluor Enterprises, a JV**Date:** 28-May-2008**Submitting Contractor:** Zhenhua Port Machinery Company, Ltd (ZPMC), Changxing Island**NCR #:** ZPMC-0132**Type of problem:**

Reference Description: Unapproved Mechanical Straightening**Description of Non-Conformance:**

Job Name: SAS Superstructure

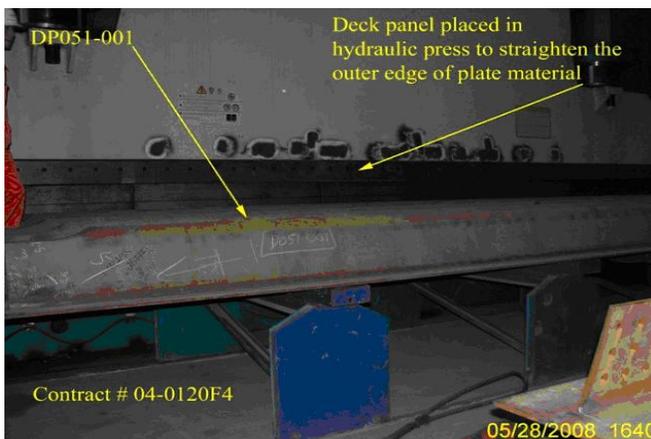
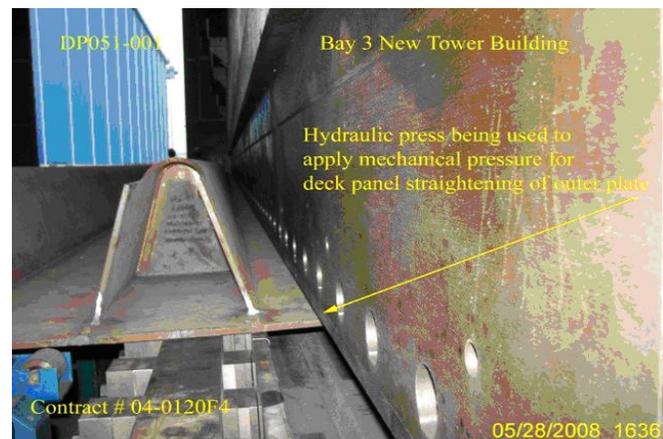
The Contractor placed the deck panel DP051-001 into a hydraulic press plate bender and applied pressure to straighten the outer edge of the panel. This straightening of the deck panel plate was not approved by the Engineer as required by AWS D1.5, Section 3.7.3 which states, "Members distorted by welding shall be straightened by mechanical means or by carefully supervised application of a limited amount of localized heat as approved by the Engineer."

AWS D1.5, Section 3.7.3: "Members distorted by welding shall be straightened by mechanical means or by carefully supervised application of a limited amount of localized heat as approved by the Engineer."

Propose a resolution for the identified non-conformance to prevent future occurrences.

The response is not acceptable. Please provide the technical justification that the member after straightening conforms to Contract requirements, and provide the member straightening and inspection records.

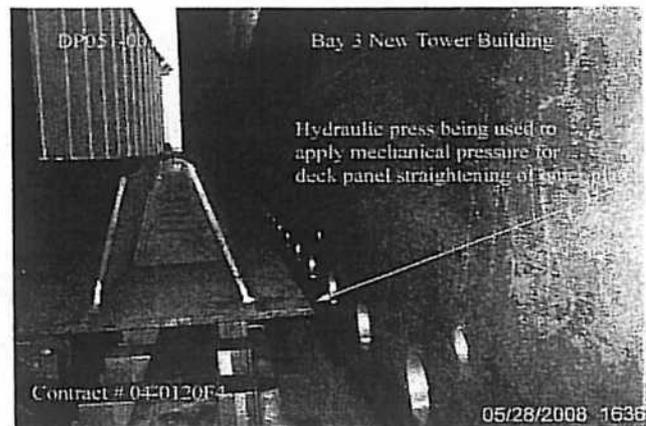
The Contractor performed straightening of members using means that have not been approved by the Engineer. The Contractor placed the deck panel DP051-001 into a hydraulic press plate bender and applied pressure to straighten the outer edge of the panel. This straightening of the deck panel plate was not approved by the Engineer as required by AWS D1.5, Section 3.7.3 which states, "Members distorted by welding shall be straightened by mechanical means or by carefully supervised application of a limited amount of localized heat as approved by the Engineer."

AWS D1.5, Section 3.7.3: "Members distorted by welding shall be straightened by mechanical means or by carefully supervised application of a limited amount of localized heat as approved by the Engineer."

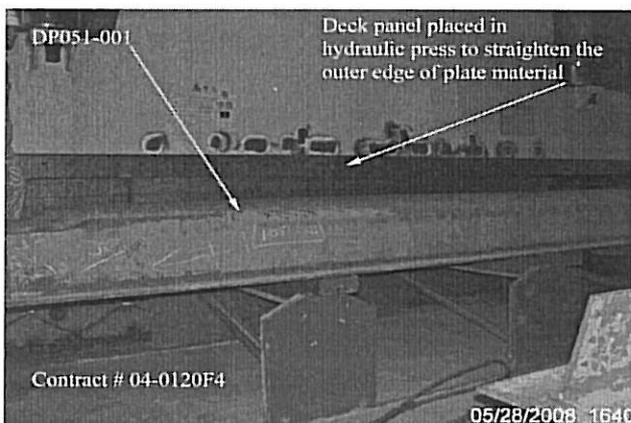
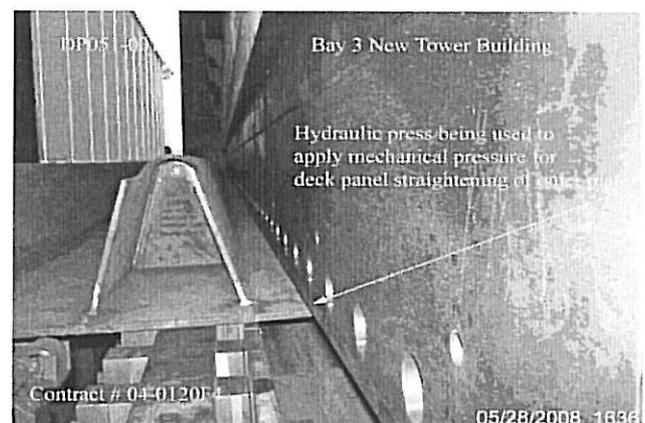
The Contractor placed the deck panel DP051-001 into a hydraulic press plate bender and applied pressure to straighten the outer edge of the panel. This straightening of the deck panel plate was not approved by the Engineer as required by AWS D1.5, Section 3.7.3 which states, "Members distorted by welding shall be straightened by mechanical means or by carefully supervised application of a limited amount of localized heat as approved by the Engineer."

AWS D1.5, Section 3.7.3: "Members distorted by welding shall be straightened by mechanical means or by carefully supervised application of a limited amount of localized heat as approved by the Engineer."

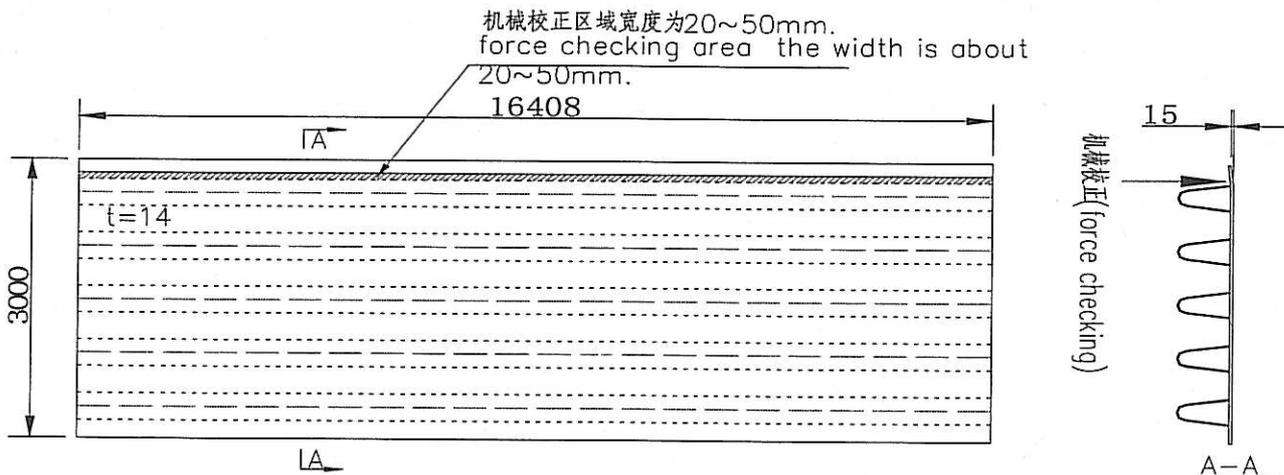
简图 Sketch

Cause 原因 Welding distortion 焊接变形

Type of Defect 缺陷类型 Welding distortion 焊接变形

Note: the max deformation is about 15mm.

缺陷去除方法(Defect Removal Method): Mechine Straightening

后续NDE(Post-Removal NDE): After finishing machine straightening, the weld of the heat area shall perform NDT according to the approved shop drawing

纠正措施(Corrective Action(s)): Control current, voltage and weld speed according to relevant WPS. If necessary anti-deformation or hold down device can be added.
