QUALITY ASSURANCE -- NON-CONFORMANCE REPORT

Report No: NCR-000139

NCR #: ZPMC-0133

Reference Description: Base metal repairs

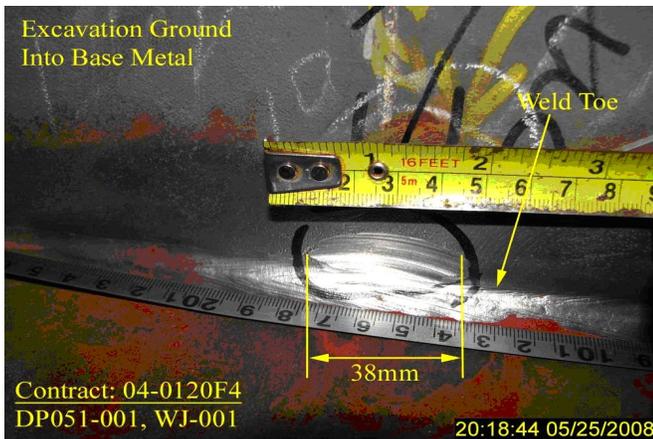
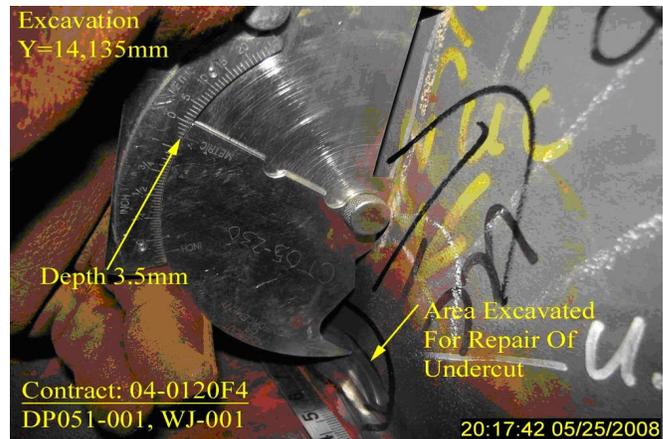
The Contractor performed base metal repairs without prior approval of the Engineer at weld joint #s -001, -002, -005, -006, -009 and -010 of deck panel DP-051-001. These six areas were ground for repair of undercut to a depth between 2mm and 3.5mm.

AWS D1.5, Section 3.7.4 "Prior approval of the Engineer shall be obtained for repairs to base metal....."

The response is not acceptable. The excavation of base metal was not described in the approved repair procedure. If the excavation of base metal is necessary for the repair of undercut, this to be incorporated into the repair procedure, and the maximum depth of the excavation of base metal is to be specified in the repair procedure.

The proposed resolution is acceptable. The repair procedure was submitted as part of ABF-SUB-634R06, and approved as noted. Also, the welds in question were accepted as shown on the attached VT, MT, and UT reports. The Department concurs that Non-Conformance ZPMC-0133 is closed.

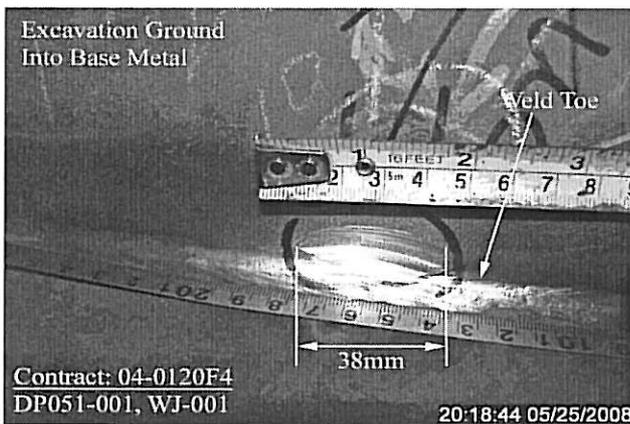
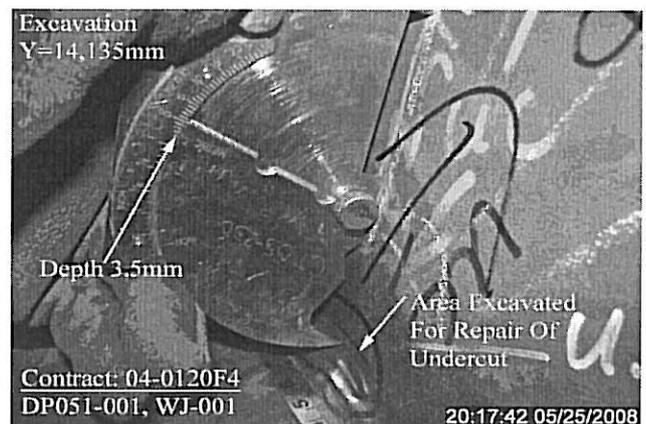
The Contractor performed base metal repairs without prior approval of the Engineer at weld joint #s -001, -002, -005, -006, -009 and -010 of deck panel DP-051-001. These six areas were ground for repair of undercut to a depth between 2mm and 3.5mm.

AWS D1.5, Section 3.7.4 "Prior approval of the Engineer shall be obtained for repairs to base metal....."

VT, MT, and UT reports for the welds in question were submitted by the Contractor showing the final examination of the weld. Also, the repair of undercut is addressed in the AAN submittal 634R06.
