Contract #: 04-0120F4Cty: SF/ALA Rte: 80 PM: 13.2/13.9File #: 69.25B**QUALITY ASSURANCE -- NON-CONFORMANCE REPORT****Location:** Changxing Island, Shanghai, PRC**Report No:** NCR-000142**Prime Contractor:** American Bridge/Fluor Enterprises, a JV**Date:** 09-Jun-2008**Submitting Contractor:** Zhenhua Port Machinery Company, Ltd (ZPMC), Changxing Island**NCR #:** ZPMC-0135**Type of problem:**

Job Name: SAS Superstructure

Subject: NCR No. ZPMC-0135

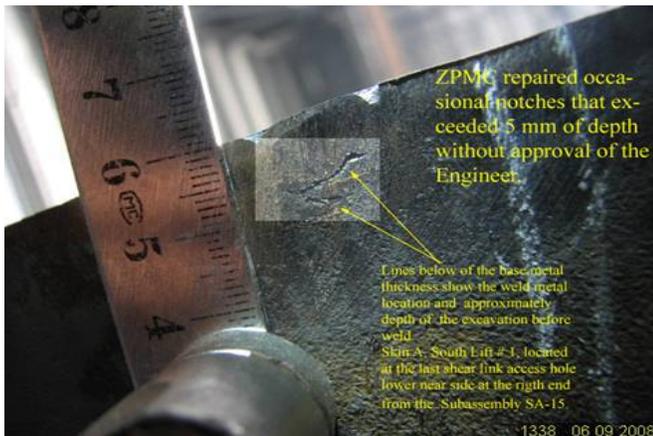
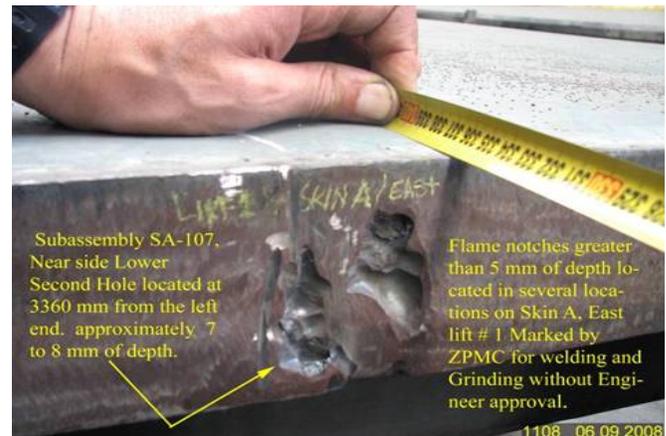
ZPMC utilized thermal cutting equipment that was not adjusted or manipulated in a manner to avoid torch notches along the edge of the skin plate. ZPMC has performed the repair of base metal notches without Engineer approval on plate edges of tension and reversal-of-stress members without performing ultrasonic testing and magnetic particle testing as required by contract documents. These notches occur at the shear link connection access holes on the South Shaft, Skin A, Lift 1.

AWS D1.5 (2002) Section 3.2.2.1 Steel, occasional notches....resulting from improper operation of the cutting process, may, with the approval of the Engineer, be repaired by welding.....Repair of members subject to tension or reversal of stress shall be inspected as described in 3.2.2.3.

Section 3.2.2.3: Welded repairs to the surfaces and edges of tension and reversal-of-stress members shall be subject to UT and MT. Weld quality shall conform to the requirements of 6.26.

Propose a resolution for the identified non-conformance that addresses both the procedures to minimize the repairs of the base metal and the corrective actions to be taken to ensure that the repairs to date are in compliance with the contract documents. In addition to the material/workmanship non-conformance, propose a resolution that addresses the failure of Quality Control to prevent the repair of the base metal without the approval of the Engineer and the steps taken by the welding Quality Control Manager to prevent future occurrences.

ZPMC QA has notified the CWIs and production personnel that ultrasonic and magnetic particle testing is required for repairs performed on thermal cut edges.
