Contract #: 04-0120F4  
 Cty: SF/ALA Rte: 80 PM: 13.2/13.9  
 File #: 69.25B

## QUALITY ASSURANCE -- NON-CONFORMANCE REPORT

**Report No:** NCR-000145

**Reference Description:** Incorrect Floorbeam Horizontal Stiffener Plates

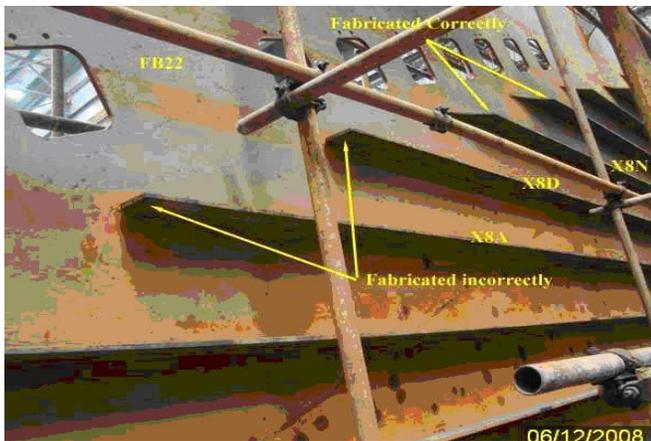
The Contractor fabricated components that do not conform to approved shop drawings. The Contractor welded two horizontal stiffener plates onto floorbeam web plate that do not have the required radius cut or 200mm CJP welded portion at the ends. This occurred at stiffener plates X8A and X8D of floorbeam FB22.

The contractor completed the repair by providing the radius cut ends for the horizontal stiffeners. QA inspector also verified by UT that the end of the two horizontal stiffener plates has a 200mm CJP weld. This repair conforms to the approved shop drawings.
