Contract #: 04-0120F4Cty: SF/ALA Rte: 80 PM: 13.2/13.9File #: 69.25B**QUALITY ASSURANCE -- NON-CONFORMANCE REPORT****Location:** Changxing Island, Shanghai, PRC**Report No:** NCR-000146**Prime Contractor:** American Bridge/Fluor Enterprises, a JV**Date:** 06-Jun-2008**Submitting Contractor:** Zhenhua Port Machinery Company, Ltd (ZPMC), Changxing Island**NCR #:** ZPMC-0138**Type of problem:**

Reference Description: Floorbeam Diagonal Support Undersized Welds**Description of Non-Conformance:**

Job Name: SAS Superstructure

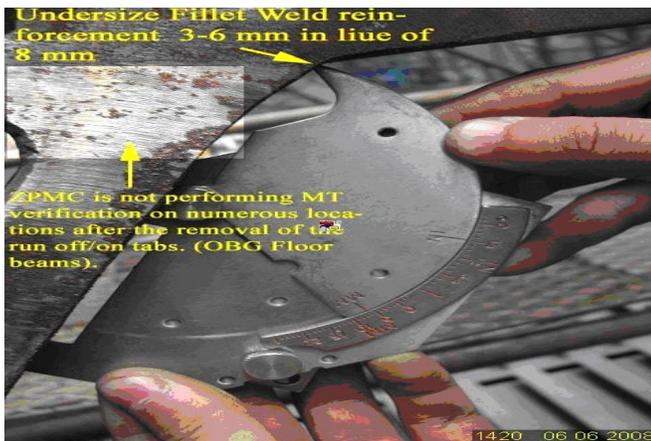
The Contractor's Quality Control accepted welds that do not conform to approved shop drawings. Fillet welds between floorbeam diagonal support connection plates and horizontal flange plate were undersized by 3 - 5mm for approximately 70 - 100% of the weld lengths. This was observed in 6 different locations on various floorbeams.

AWS D1.5, Section 6.26.1.7: "A fillet weld in any single continuous weld may underrun the nominal fillet weld size specified by 2 mm [1/16 in.] without correction, provided that the undersize portion of the weld does not exceed 10 percent of the length of the weld."

ZPMC did not measure these fillet welds correctly, undersize fillet welds will require additional weld, as well as visual and NDT of the welds as required in the contract. ZPMC has been instructed by ABF QA personnel on measurement techniques for this skewed joint design.

The Contractor acknowledged ZPMC did not measure these fillet welds correctly, undersized fillet welds will require additional weld, as well as visual and NDT of the welds as required in the contract.

ZPMC has been instructed by ABF QA personnel on measurement techniques for this skewed joint design.
