Contract #: 04-0120F4Cty: SF/ALA Rte: 80 PM: 13.2/13.9File #: 69.25B**QUALITY ASSURANCE -- NON-CONFORMANCE REPORT****Location:** Changxing Island, Shanghai, PRC**Report No:** NCR-000152**Prime Contractor:** American Bridge/Fluor Enterprises, a JV**Date:** 23-Jun-2008**Submitting Contractor:** Zhenhua Port Machinery Company, Ltd (ZPMC), Changxing Island**NCR #:** ZPMC-0143**Type of problem:**

<b>Welding</b>	<b>Concrete</b>	<b>Other</b>	
<b>Welding</b>	<b>Curing</b>	<b>Procedural</b>	<b>Bridge No:</b> 34-0006
<b>Joint fit-up</b>	<b>Coating</b>	<b>Other</b>	<b>Component:</b> Segment 3BE
<b>Procedural</b>	<b>Procedural</b>	<b>Descriptor:</b>	OBG Segment Assembly

**Job Name:** SAS Superstructure

**Subject:** NCR No. ZPMC-0143

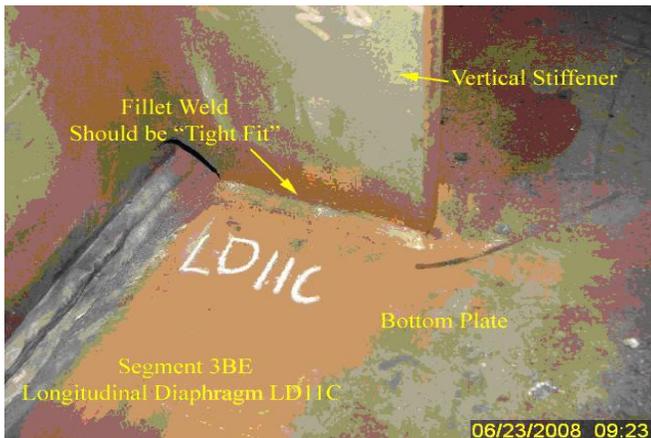
The Contractor fabricated components that do not conform to approved working drawings. The bottom of vertical stiffeners, located on the longitudinal diaphragms, have been fillet welded to the bottom plates BP10A and the BP12A. The shop drawings note "Tight Fit" and "No Weld" between the vertical stiffener and the bottom plates. The following longitudinal diaphragms have had the vertical stiffener welded to the bottom plates: LD11C-001, LD12C, LD008-002, LD006B-001.
