QUALITY ASSURANCE -- NON-CONFORMANCE REPORT

Report No: NCR-000153

NCR #: ZPMC-0144

Reference Description: Improper Underfill Repair

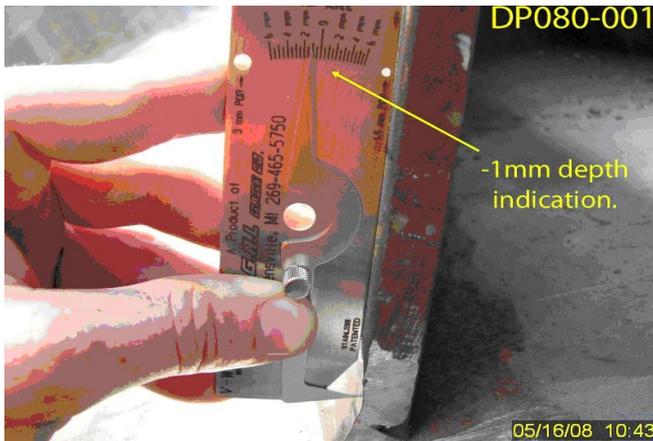
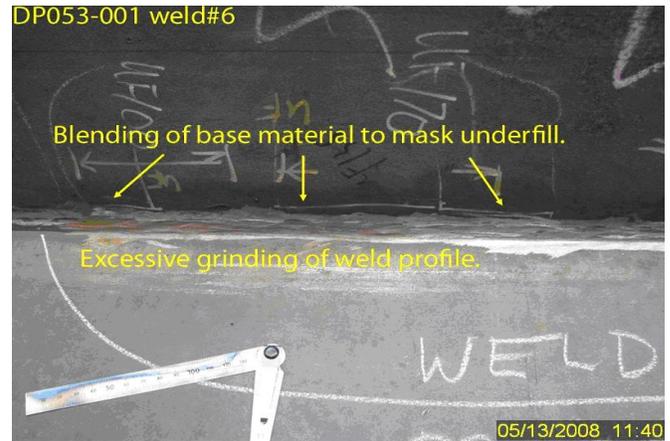
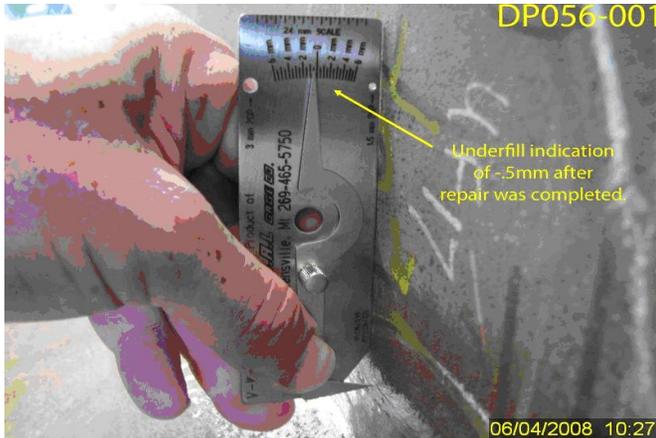
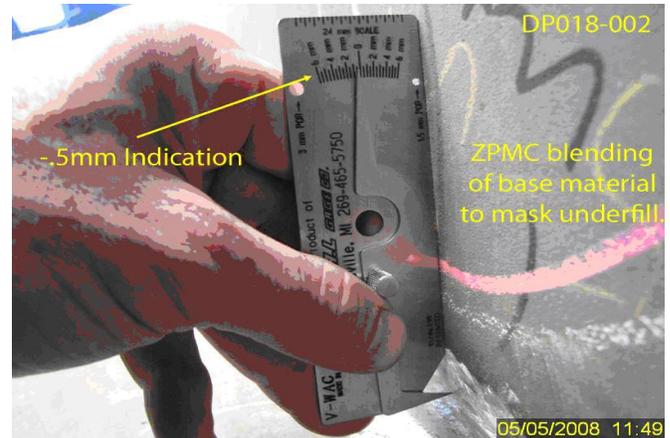
The Contractor performed weld repairs using unapproved procedures. On multiple occasions, the Contractor was observed grinding OBG closed rib base metal to mask areas of underfill. Approved closed rib weld repair procedures require that underfill be repaired with deposition of additional weld metal prior to grinding. This was observed in various deck panels undergoing repairs.

ZPMC has been notified that grinding of undercut for repair does not conform to the approved external weld repair procedure and shall be repaired per the external weld repair procedure. Please note that the instrument used in measuring undercut is only indicated in 1mm increments and cannot be a 100% accurate measurement, but an estimate of some measurement over .25mm in depth. The picture in the NCR only states <1mm.

ZPMC has been notified that grinding of undercut for repair does not conform to the approved external weld repair procedure and shall be repaired per the external weld repair procedure.
