QUALITY ASSURANCE -- NON-CONFORMANCE REPORT

Report No: NCR-000155

NCR #: ZPMC-0146

Welding	Concrete	Other	
Welding	Curing	Procedural	Bridge No: 34-0006
Joint fit-up	Coating	Other	Component: 89m Mock-up
Procedural	Procedural	Descriptor: 89m Fit Lug Partial Mock-up

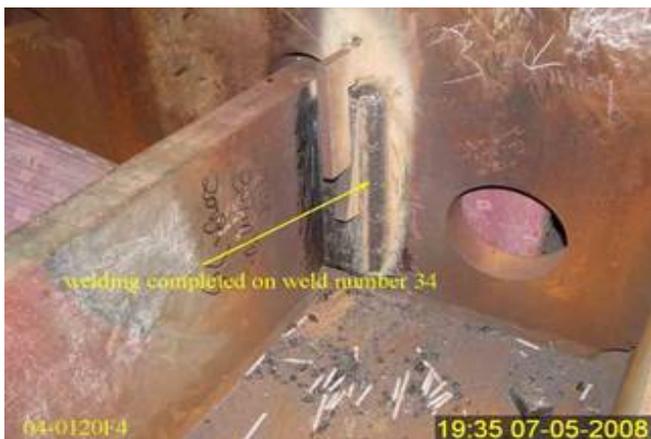
Caltrans Quality Assurance Ken Riley observed the following deviation by ZPMC from the approved partial mock-up procedure (ABF-SUB101R2).

1) ZPMC welded the fit lug to the diaphragm (MUB-MA21A/J-34) first which deviated from Step 3c of the procedure where the weld was to be welded second after the fit lug was welded to the longitudinal stiffener.

Reference Resolution: ZPMC's QA/QC and Production personnel have been instructed on the importance to comply with approved procedures.

ZPMC acknowledges they deviated from the approved partial mock-up procedure (ABF-SUB101R2. ZPMC's QA/QC and Production personnel have been instructed on the importance to comply with approved procedures, if procedures cannot be complied with, they shall first be revised and approved prior to work being performed.
