Contract #: 04-0120F4Cty: SF/ALA Rte: 80 PM: 13.2/13.9File #: 69.25B**QUALITY ASSURANCE -- NON-CONFORMANCE REPORT****Location:** Changxing Island, Shanghai, PRC**Report No:** NCR-000164**Prime Contractor:** American Bridge/Fluor Enterprises, a JV**Date:** 07-Jul-2008**Submitting Contractor:** Zhenhua Port Machinery Company, Ltd (ZPMC), Changxing Island**NCR #:** ZPMC-0151**Type of problem:**

Reference Description: Unapproved Closed Rib UT Repairs**Description of Non-Conformance:**

Subject: NCR No. ZPMC-0151

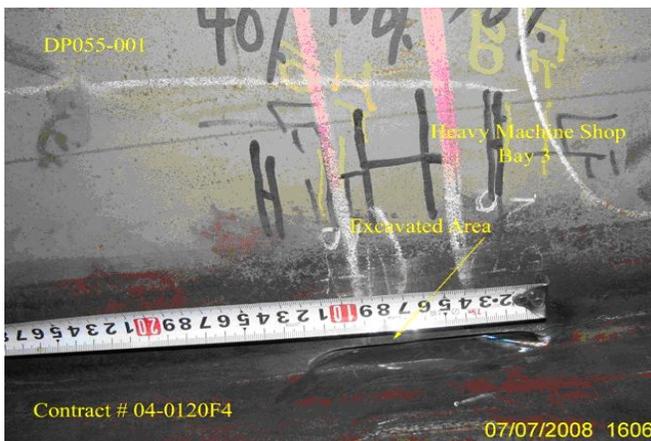
The Contractor performed weld repairs without prior Engineer approval. The Contractor performed internal weld repairs for the lack of penetration (LOP) of OBG deck panel closed rib welds. The Contractor has not satisfied the Engineer's request to demonstrate repair of LOP prior to performing the repairs. This incident happened on deck panels DP055-001, DP067-001 and DP015-001. See photograph for more detail:

Propose a resolution for the identified non-conformance with revised procedures to prevent future occurrences.

The repair procedure (ABF-SUB-000634R02) was Approved As Noted. The combination of demonstrations held on May 21, 2008 and June 11, 2008 fulfilled the requirement stated in Submittal ABF-SUB-000634R02.
