## QUALITY ASSURANCE -- NON-CONFORMANCE REPORT

**Report No:** NCR-000166

**Reference Description:** Incorrect welding of T Stiffeners Splice Backing

**Job Name:** SAS Superstructure

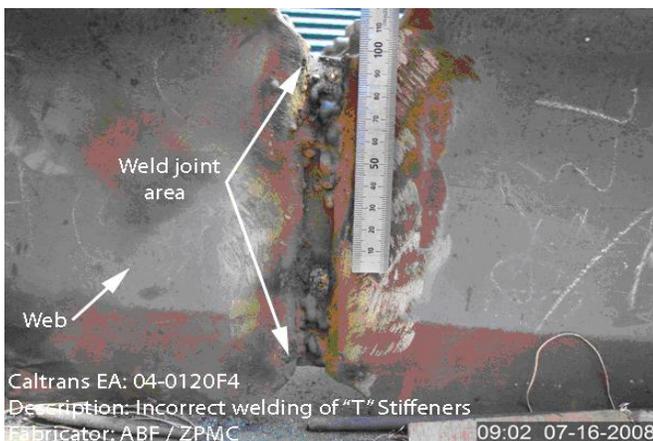
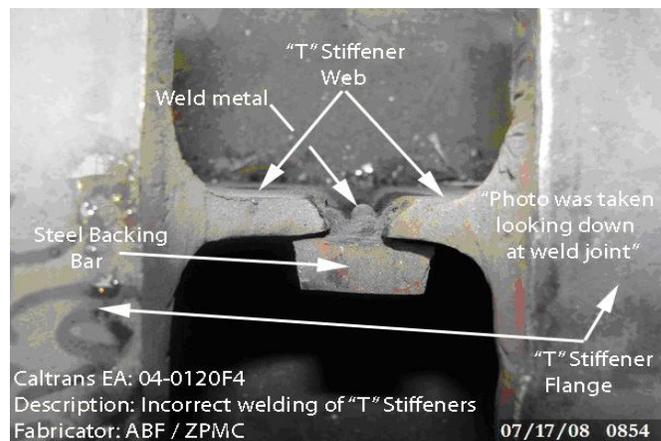
The Contractor performed welding that did not conform to approved working drawings and did not conform to workmanship requirements of the specifications. The Contractor performed welding with steel backing where it was not called out for in the approved weld detail. The Contractor performed welding that did not terminate in a manner to ensure sound welds. This was observed in the longitudinal T-stiffeners on side panel web splice SP069-001 of segment SEG 3AW.

Below are two digital photographs illustrating this discrepancy.

AWS D1.5, Sec. 3.12.1: "Welds shall be terminated at the end of a joint in a manner that will ensure sound welds."

ZPMC used back-up bar to complete this joint due to the root gap being too large for a pin back-up bar weld. ZPMC then removed the backing bar and performed inspections as required for this weld joint. ABF has instructed ZPMC to revise the Weld Detail if they anticipate this occurrence to repeat.

Propose a resolution for the identified non-conformance with revised procedures to prevent future occurrences.

The proposed resolution is acceptable. The welding repair report for the repair is included, and the welds in question have been accepted by VT and UT as shown in the attached documents. The Department concurs that Non-Conformance ZPMC-0153 is closed.

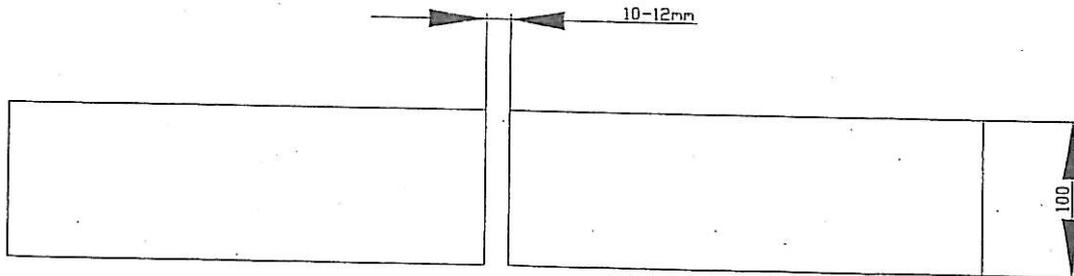
The butt gap of T rib of the 3AW segment bottom SP45B, SP57B and SP69B is 10-12 mm. The weld no. is SP045-001-051/052/053/054/055/056/057, SP057-001-064, SP069-001-056.

The operator performed mistakenly when cutting the tolerance, leading to the butt gap between T-ribs over the requirement.

1. Prepare excavation with relevant WPS.
2. VT and MT to verify repair area is free of all defects.
3. Add steel backing at the back of groove according to AWS D1.5.3.13;
4. Preheat and weld according to the relevant WPS.
5. Gouge off the steel backing and grind the weld flush with base metal after welding;
6. Perform NDT inspection of the weld according to the working drawings.

1. 对施工队批评指导
  2. 余量线划出时建议检验员确认后再进行修割
  3. 加强现场监控
- 1, Criticize and supervise the fabrication team.
  - 2, Perform cutting after the tolerance line is confirmed by the inspector.
  - 3, Enhance the monitoring on site.
