Contract #: 04-0120F4Cty: SF/ALA Rte: 80 PM: 13.2/13.9File #: 69.25B**QUALITY ASSURANCE -- NON-CONFORMANCE REPORT****Location:** Changxing Island, Shanghai, PRC**Report No:** NCR-000171**Prime Contractor:** American Bridge/Fluor Enterprises, a JV**Date:** 03-Jul-2008**Submitting Contractor:** Zhenhua Port Machinery Company, Ltd (ZPMC), Changxing Island**NCR #:** ZPMC-0155**Type of problem:**

**Reference Description:** Unapproved base metal repair EP-17B, 5B**Description of Non-Conformance:**

**Job Name:** SAS Superstructure

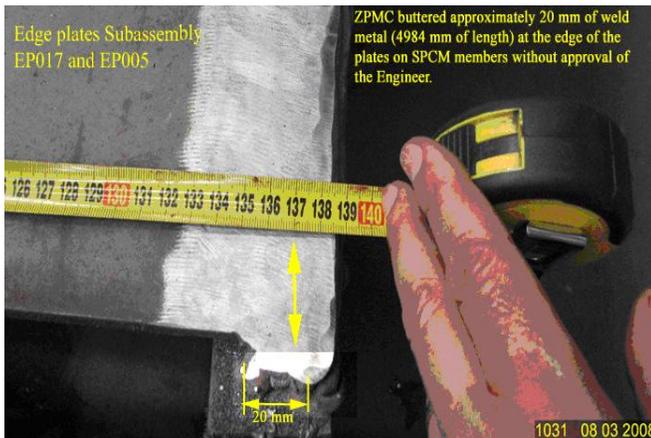
The Contractor performed critical weld repair on SPCM material without Engineer approval. The Contractor corrected the length of edge panels by building up with weld metal to an approximate length of 20mm without prior Engineer approval. The maximum allowable thickness of weld to be deposited is 4.5mm for edge plates with nominal thickness of 18mm. This occurred on edge panels EP017 and EP005.

AWS D1.5, Sec. 12.17.2.(7): "Deposition of weld metal up to 10 mm deep, or 1/4 the base-metal thickness, whichever is less to correct for length of joint geometry."

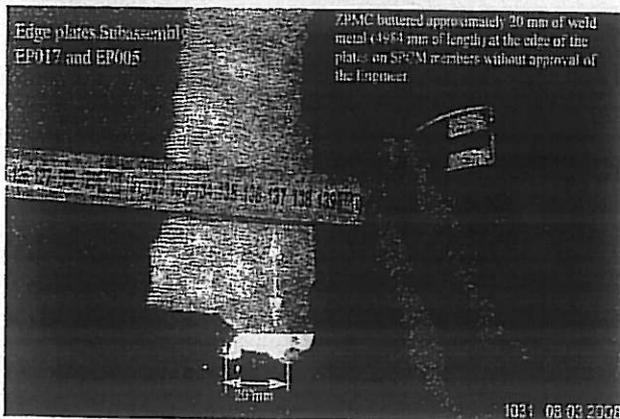
The Contractor performed critical weld repair on SPCM material without Engineer approval. The Contractor corrected the length of edge panels by building up with weld metal to an approximate length of 20mm without prior Engineer approval. The maximum allowable thickness of weld to be deposited is 4.5mm for edge plates with nominal thickness of 18mm. This occurred on edge panels EP017 and EP005.

AWS D1.5, Sec. 12.17.2.(7): "Deposition of weld metal up to 10 mm deep, or 1/4 the base-metal thickness, whichever is less to correct for length of joint geometry."

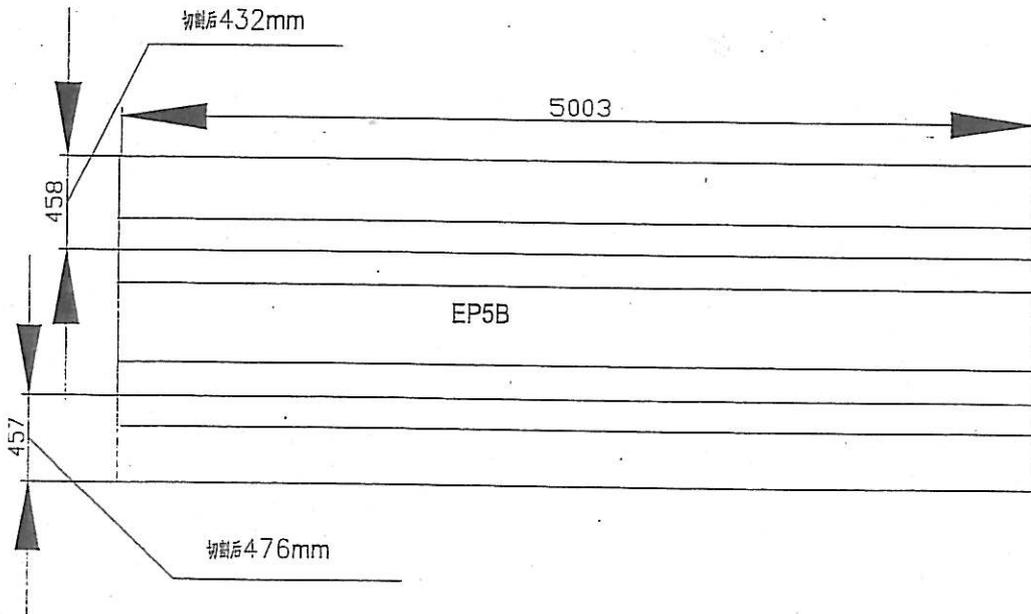
### 焊缝返修位置示意图:

The EP5B of 3A-E corner section was cut more 16mm by Work Team: Hu Guoxing; the follo wing shows the detail position.

There is some error during fixing on ACL causing the cutting line offset 16mm.

1. Verify with VT and MT repair area is free of all defects.
2. Add ceramic backing according to the attached drawing 1;
3. Preheat and weld according to the relevant WPS and dimension of lineament is more than 5-6mm necessary actual dimension;
4. Remove the ceramic backing and grind the weld flush with around metal;
5. Perform post NDT (VT MT UT) of repaired area to insure sound weld metal has been deposited.
6. Prepare cutting again according to the shop drawings

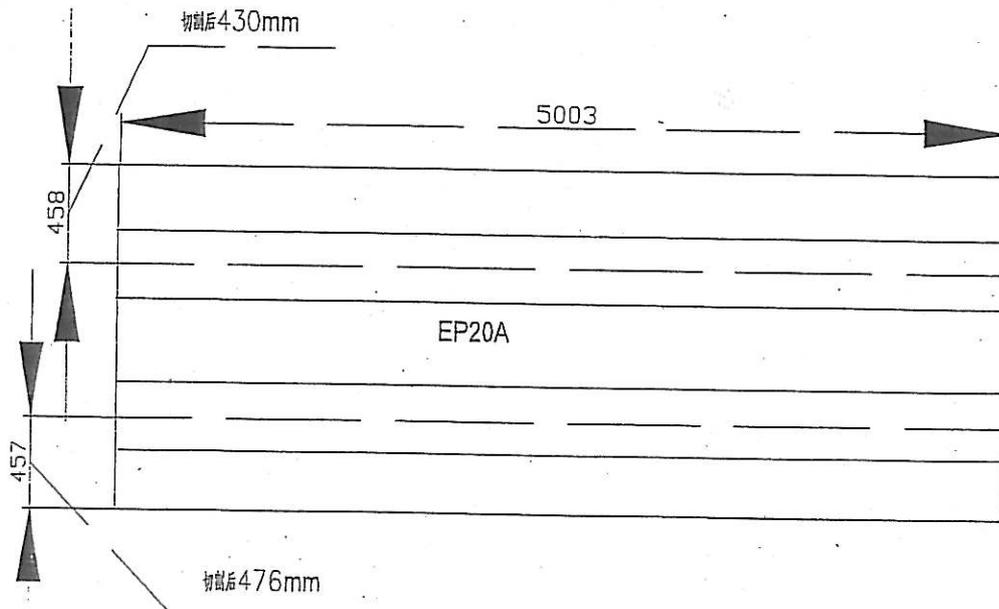
### 焊缝返修位置示意图:

The EP20A of 4B-E corner section was cut more 18mm by Work Team: Hu Guoxing; the following shows the detail position.

There is some error during fixing on ACL causing the cutting line offset 18mm.

1. Verify with VT and MT repair area is free of all defects.
2. Add ceramic backing according to the attached drawing 1;
3. Preheat and weld according to the relevant WPS and dimension of lineament is more than 5-6mm necessary actual dimension;
4. Remove the ceramic backing and grind the weld flush with around metal;
5. Perform post NDT (VT MT UT) of repaired area to insure sound weld metal has been deposited.
6. Prepare cutting again according to the shop drawings
