Contract #: 04-0120F4Cty: SF/ALA Rte: 80 PM: 13.2/13.9File #: 69.25B**QUALITY ASSURANCE -- NON-CONFORMANCE REPORT****Location:** Changxing Island, Shanghai, PRC**Report No:** NCR-000173**Prime Contractor:** American Bridge/Fluor Enterprises, a JV**Date:** 08-Aug-2008**Submitting Contractor:** Zhenhua Port Machinery Company, Ltd (ZPMC), Changxing Island**NCR #:** ZPMC-0157**Type of problem:****Welding****Concrete****Other****Welding****Curing****Procedural****Bridge No:** 34-0006**Joint fit-up****Coating****Other****Component:** Tower Type 3B Diaphragm**Procedural****Procedural****Descriptor:** Tower Diaphragm ESD1-SA316 B/B**Reference Description:** 04-0120F4 Special Provisions**Description of Non-Conformance:**

Job Name: SAS Superstructure

Subject: NCR No. ZPMC-0157

Reference Description: Failure to follow Approved Procedure / Weld Sequence / Tower Diaphragm Assembly

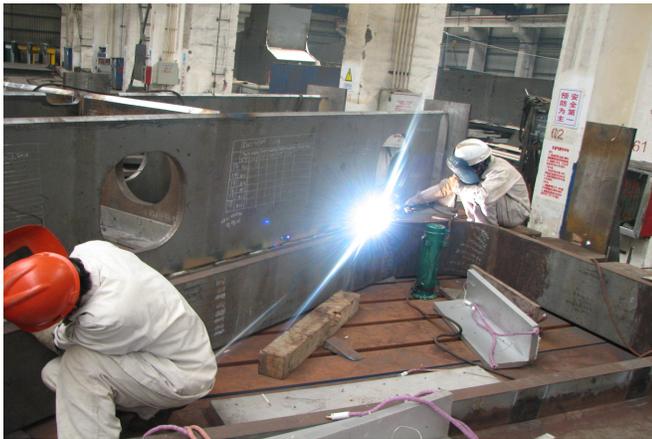
ZPMC was observed welding the root pass of weld joints 3 and 4 of the partial joint penetration connection of 40mm web plate to (bottom) tower diaphragm plate ESD1-SA316 B/B, without tack welding/installing the top tower diaphragm plate. This sequence is not in conformance with steps 2 and 3 on page FP-MUA-20 of the 77m Diaphragm Type 3B Fabrication Procedure which shows the fit up and tack welding of both the top and bottom diaphragms prior to welding the root passes.

The Contractor has submitted preliminary survey data showing that the change in step did not cause distortion of the web plates. The Contractor plans to submit further data which shows if the bottom diaphragm which recieved the root pass was distorted.

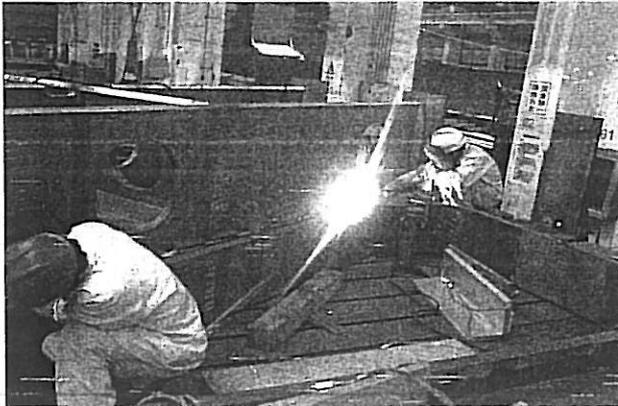
ZPMC was observed welding the root pass of weld joints 3 and 4 of the partial joint penetration connection of 40mm web plate to (bottom) tower diaphragm plate ESD1-SA316 B/B, without tack welding/installing the top tower diaphragm plate. This sequence is not in conformance with steps 2 and 3 on page FP-MUA-20 of the 77m Diaphragm Type 3B Fabrication Procedure which shows the fit up and tack welding of both the top and bottom diaphragms prior to welding the root passes.

The Contractor has submitted preliminary survey data showing that the change in step did not cause distortion of the web plates. The Contractor plans to submit further data which shows if the bottom diaphragm which recieved the root pass was distorted.
