Contract #: 04-0120F4
 Cty: SF/ALA Rte: 80 PM: 13.2/13.9
 File #: 69.25B

QUALITY ASSURANCE -- NON-CONFORMANCE REPORT

Location: Changxing Island, Shanghai, PRC **Report No:** NCR-000191
Prime Contractor: American Bridge/Fluor Enterprises, a JV **Date:** 04-Sep-2008
Submitting Contractor: Zhenhua Port Machinery Company, Ltd (ZPMC), Changxing Island **NCR #:** ZPMC-0172

Reference Description: Welds that do not conform to detail drawings

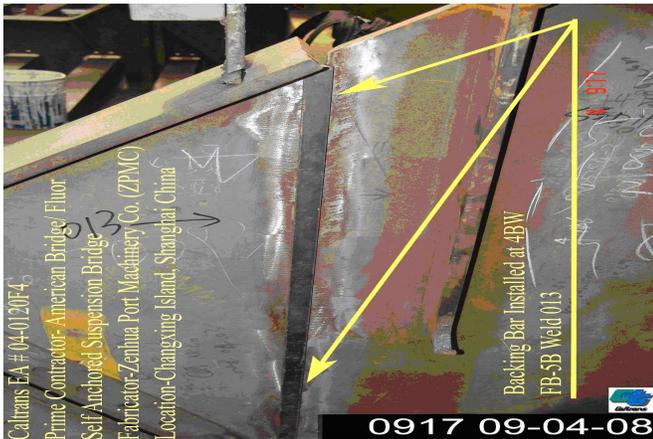
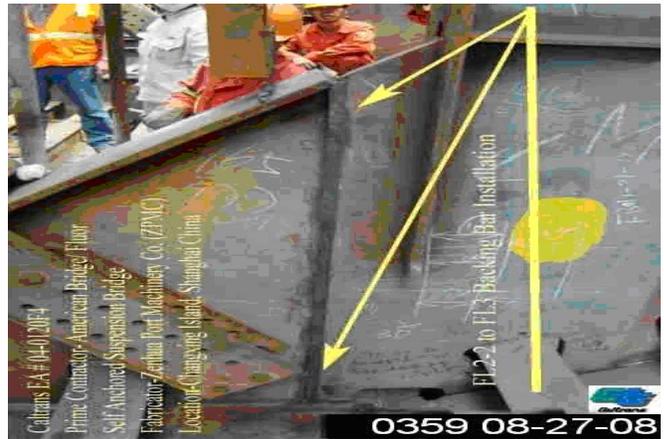
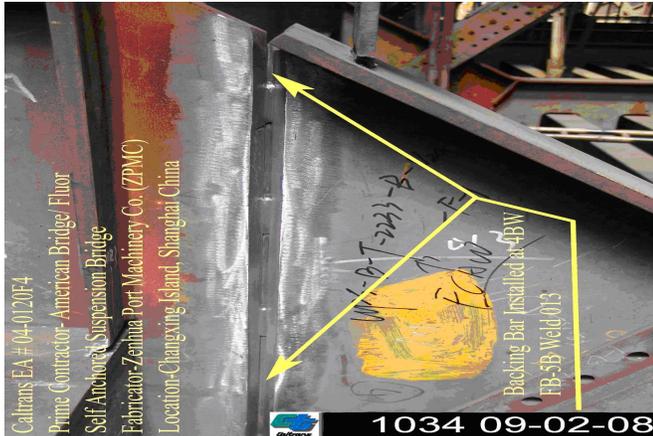
The Contractor's QC allowed welds that do not conform to detail drawings to be performed in fabrication. The Contractor installed backing bars at locations where backing bars have not been specified. This was observed in weld joints 4BW-SSD11-PP027-013 of OBG segment SEG 4BW and 3AW-SSD12-PP022-133 of OBG SEG3AW.

AWS D1.5, Sec. 6.5.1: "The Inspector shall make certain that the size, length, location of all welds conform to the requirements of this code and to the detail drawings and that no unspecified welds have been added without approval."

ZPMC installed back-up bars per WPS BT2213-B-U2-F-1 because the root gap was in excess of that allowed for the approved WPS for that joint type. Once the weld was completed with the back-up bar in place, the back-up bars were then removed, the weld back gouged on the back-up bar removal side and finished welded. The weld then received the required Visual and NDT inspection.

The backing bar was removed. The current weld condition conforms to the detail drawing.
