QUALITY ASSURANCE -- NON-CONFORMANCE REPORT

Report No: NCR-000193

Reference Description: Diaphragm Installation Unapproved Repairs

Job Name: SAS Superstructure

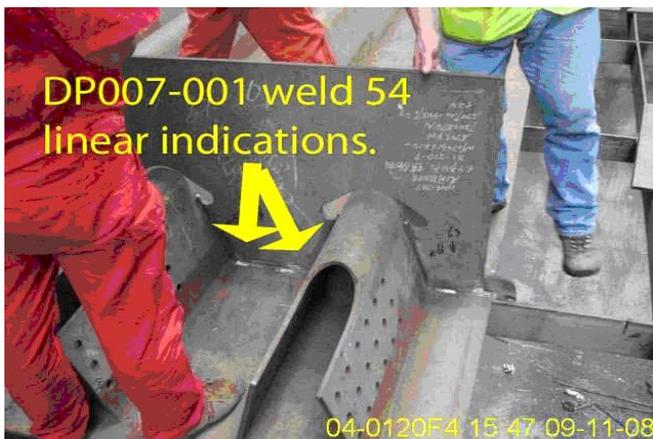
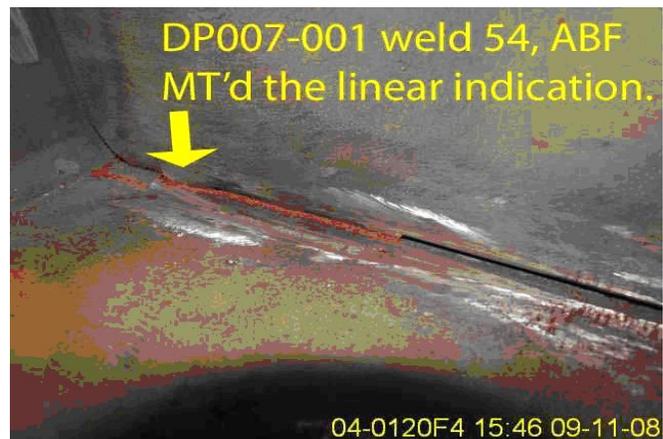
The Contractor has not complied with the written order of the Engineer to suspend work. The Contractor has welded diaphragm plates to deck panel DP007-001. Additionally, the Contractor performed unapproved repairs to cracks and base metal on the non-compliant welds. This was observed on weld joint # -0054 of deck panel DP007-001.

Special Provisions, Sec. 8-3.01 Welding Quality Control (p. 154): "In addition to the provisions in AWS D1.5, Section 3.7.4 and Section 12.17, third-time repairs of welds or base metal, regardless of NDT method, and all repairs of cracks require prior approval of the Engineer."

The proposed resolution is not acceptable. Repairs to crater cracks and cracks in tack welds can be done without Engineer approval on non-SPCM material, but not repairs to base metal. Weld repairs to base metal, which were part of Non-Conformance ZPMC-0174, require prior approval of the Engineer.

Please provide documentation of the weld repairs that were performed and that the repairs were acceptable. The Department will review the Contractor's proposal to close Non-Conformance ZPMC-0174 at that time.

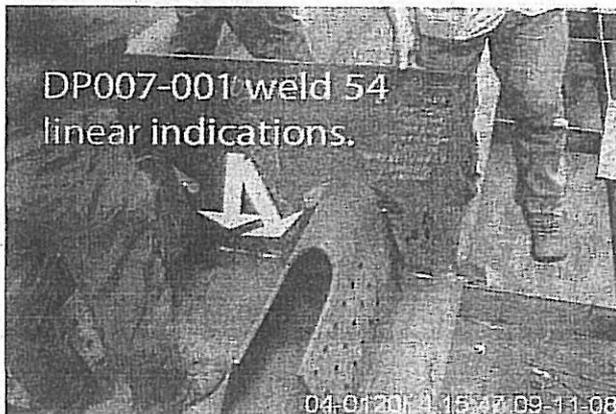
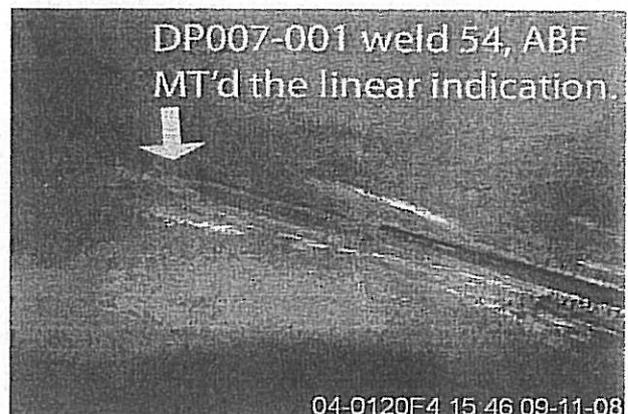
The Contractor has not complied with the written order of the Engineer to suspend work. The Contractor has welded diaphragm plates to deck panel DP007-001. Additionally, the Contractor performed unapproved repairs to cracks and base metal on the non-compliant welds. This was observed on weld joint # -0054 of deck panel DP007-001.

Special Provisions, Sec. 8-3.01 Welding Quality Control (p. 154): "In addition to the provisions in AWS D1.5, Section 3.7.4 and Section 12.17, third-time repairs of welds or base metal, regardless of NDT method, and all repairs of cracks require prior approval of the Engineer."
