Contract #: 04-0120F4Cty: SF/ALA Rte: 80 PM: 13.2/13.9File #: 69.25B**QUALITY ASSURANCE -- NON-CONFORMANCE REPORT****Location:** Changxing Island, Shanghai, PRC**Report No:** NCR-000195**Prime Contractor:** American Bridge/Fluor Enterprises, a JV**Date:** 04-Sep-2008**Submitting Contractor:** Zhenhua Port Machinery Company, Ltd (ZPMC), Changxing Island**NCR #:** ZPMC-0176**Type of problem:**

QUALITY ASSURANCE -- NON-CONFORMANCE REPORT

Contract #: 04-0120F4Cty: SF/ALA Rte: 80 PM: 13.2/13.9File #: xx.25A**QUALITY ASSURANCE -- NON-CONFORMANCE RESOLUTION****Location:** Changxing Island, Shanghai, PRC**Report No:** NCS-000094**Prime Contractor:** American Bridge/Fluor Enterprises, a JV**Date:** 24-Sep-2008**Submitting Contractor:** Zhenhua Port Machinery Company, Ltd (ZPMC), Changxing Island **NCR #:** ZPMC-0176**Type of problem:**

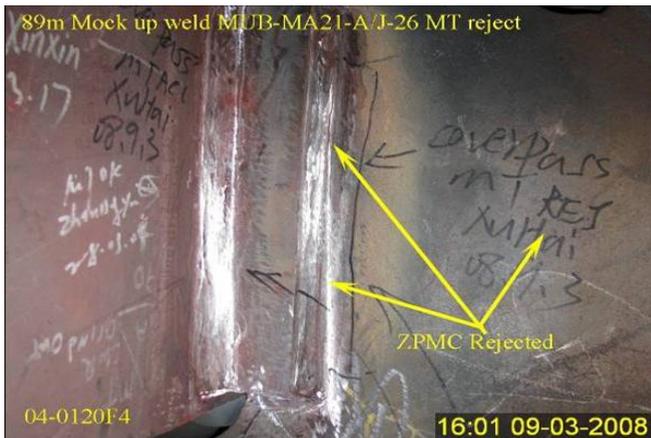
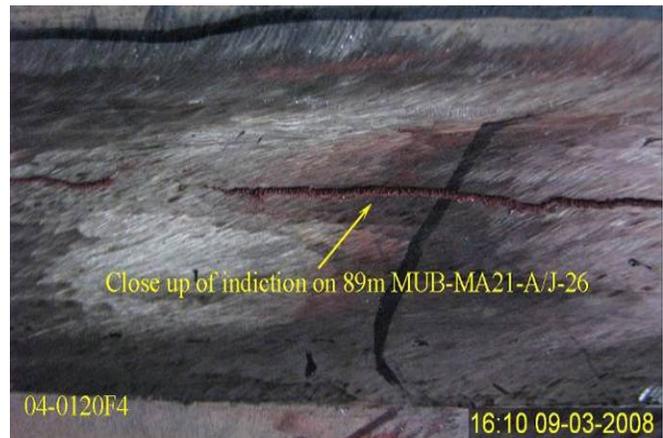
ABF/ZPMC welded the 89m Partial mock-up fit lug to diaphragm connection (MUB-MA21-A/J-26) on 09/02/08 and performed the MT inspection 24 hours after completion welding on 09/03/08. During the MT inspection a 250 mm crack was discovered. Weld cracks, as defined by AWS D1.5, are considered unsatisfactory is not in conformance according to Special Provisions, Section 10-1.59, "Fabrication/Erection Procedure and Mock-Ups", Page 313, paragraph B.1. and AWS D1.5 sec. 6.26.1.1.

ABF has rejected this fit lug weld and concurs with the Department that it is unacceptable.

None required, ABF has rejected the cracked fit lug.
