Contract #: 04-0120F4Cty: SF/ALA Rte: 80 PM: 13.2/13.9File #: 69.25B**QUALITY ASSURANCE -- NON-CONFORMANCE REPORT****Location:** Changxing Island, Shanghai, PRC**Report No:** NCR-000197**Prime Contractor:** American Bridge/Fluor Enterprises, a JV**Date:** 09-Sep-2008**Submitting Contractor:** Zhenhua Port Machinery Company, Ltd (ZPMC), Changxing Island**NCR #:** ZPMC-0177**Type of problem:**

<b>Welding</b>	<b>Concrete</b>	<b>Other</b>	
<b>Welding</b>	<b>Curing</b>	<b>Procedural</b>	<b>Bridge No:</b> 34-0006
<b>Joint fit-up</b>	<b>Coating</b>	<b>Other</b>	<b>Component:</b> OBG SEG 5CE, various SSD joints
<b>Procedural</b>	<b>Procedural</b>	<b>Descriptor:</b>	OBG floorbeam sloping flange plate connection

**Reference Description:** Undersized Reinforcement**Description of Non-Conformance:**

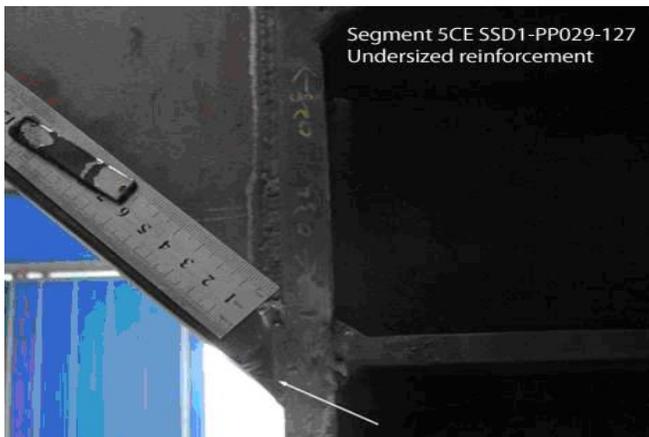
QA observed numerous sloping flange plate connections with undersized reinforcement. Weld detail WD20N requires a reinforcing fillet to be 5 millimeters on the acute side, and 8 millimeters on the obtuse side. The following is a list of weld numbers accepted by ZPMC visually and by the required non-destructive testing. SSD19-PP029-131, SSD19-PP029-127, SSD17A-PP021-009, SSD17A-PP021-126, SSD13A-PP036-131, and SSD13A-PP036-127. QA observed several others of the same connection that appears to be completed however it is not clear that ZPMC has completed visual and non destructive testing requirements.

The Contractor is to provide documentation for the necessary repairs for the undersized reinforcement.  
Also propose a resolution for the identified non-conformance with revised procedures to prevent future occurrences.

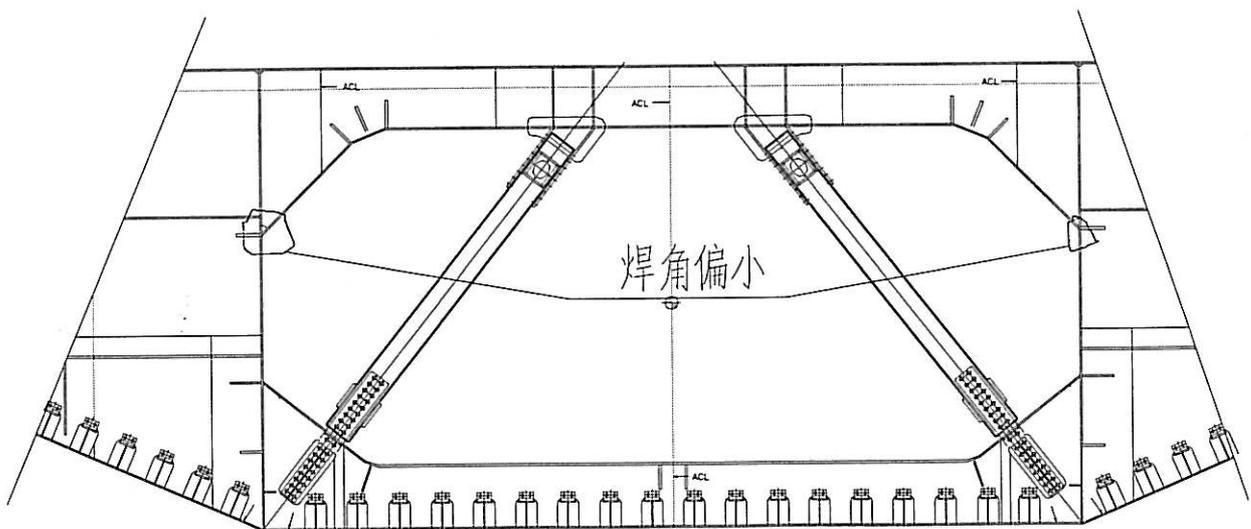
**Draft of welding discontinuity:**

Weld size of SSD17-PP021-126\SSD17A-PP021-009\SSD13-PP036-131\SSD13A-PP036-127 was 2-3mm shorter than technology requirement, the following shows the detail position.

1. Weld size was in the error range after welding, but it was shorter than AWS requirement after grinding.

1. Continue to weld according to the shop drawing and grind the repaired weld flush with the base metal  
Or adjacent weld smoothly.

- 1、成型焊缝结束后及时测量，然后在进行下道工序。
  - 2、严格按照工艺流程及WPS要求施工。
1. Measure weld size immediately before doing next process;
  2. Perform according to technology procedure and WPS requirement.
