Contract #: 04-0120F4Cty: SF/ALA Rte: 80 PM: 13.2/13.9File #: 69.25B**QUALITY ASSURANCE -- NON-CONFORMANCE REPORT****Location:** Changxing Island, Shanghai, PRC**Report No:** NCR-000201**Prime Contractor:** American Bridge/Fluor Enterprises, a JV**Date:** 20-Sep-2008**Submitting Contractor:** Zhenhua Port Machinery Company, Ltd (ZPMC), Changxing Island**NCR #:** ZPMC-0179**Type of problem:**

Job Name: SAS Superstructure

Subject: NCR No. ZPMC-0179

Reference Description: Failure to Identify Indication and Obtain Approval of Repair / Diaphragm Assembly / Lift 1

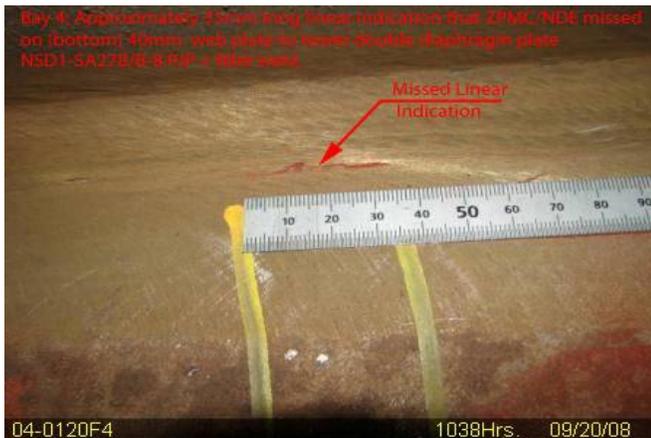
Quality Assurance identified a 35mm linear indication during magnetic particle testing, indicative of crack in the PJP groove weld, 43M Diaphragm plate weld number NSD1-SA27 B/B-8. ZPMC Quality Control Inspectors had previously tested and accepted the weld using magnetic particle testing and turned over the weld for Quality Assurance verification testing. Once the crack was identified ZPMC repaired the indication without approval from the Engineer as is required by the Special Provisions and AWS D1.5 2002.

AWS D1.5, Section 3.7.4 and Section 12.17 and Special Provisions, Section 8-3, "In addition to the provisions in AWS D1.5, Section 3.7.4 and Section 12.17, third-time repairs of welds or base metal, regardless of NDT method, and all repairs of cracks require prior approval of the Engineer."

Propose a resolution for the identified non-conformance, documenting that the repaired weld is in compliance with the contract requirements. Documentation provided for the Engineer's review of the acceptability of the weld repair shall at a minimum include the procedure utilized/CWR and the NDT results.

In addition to the material/workmanship non-conformance, propose a resolution that addresses the failure of Quality Control to identify the linear indication (NDT) and once identified allowing the repair to proceed without a CWR approved by the Engineer. Provide documentation of the steps taken by the Quality Control Manager to prevent future occurrences.

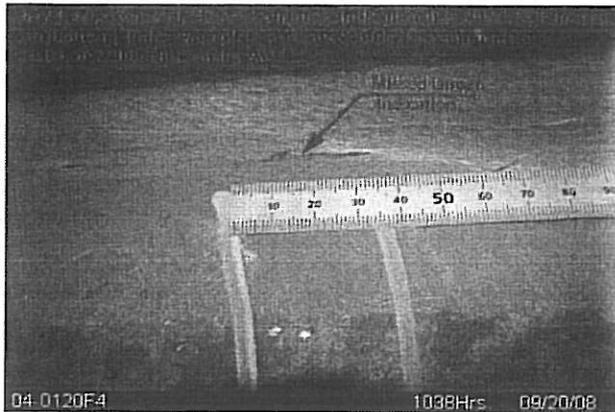
Quality Assurance identified a 35mm linear indication during magnetic particle testing, indicative of crack in the PJP groove weld, 43M Diaphragm plate weld number NSD1-SA27 B/B-8. ZPMC Quality Control Inspectors had previously tested and accepted the weld using magnetic particle testing and turned over the weld for Quality Assurance verification testing. Once the crack was identified ZPMC repaired the indication without approval from the Engineer as is required by the Special Provisions and AWS D1.5 2002.

AWS D1.5, Section 3.7.4 and Section 12.17 and Special Provisions, Section 8-3, "In addition to the provisions in AWS D1.5, Section 3.7.4 and Section 12.17, third-time repairs of welds or base metal, regardless of NDT method, and all repairs of cracks require prior approval of the Engineer."

ZPMC has provided Magnetic Particle Testing (MT) results indicating sound welds and the 43M Diaphragm has been green tagged. ZPMC has also provided dry Magnetic Particle Testing (MT) training to its NDT operators to prevent future occurrences, as indicated in their response to NCR-ZPMC-0187.
